# PRE-DEMOLITION POTENTIALLY HAZARDOUS MATERIALS BUILDING INSPECTION REPORT

**CORNELL ELEMENTARY SCHOOL  
4371 CORNELL ROAD  
OKEMOS, MICHIGAN 48864**

**ERG PROJECT NO.: 240558**

**REVISED FINAL REPORT DATE: AUGUST 8, 2025**

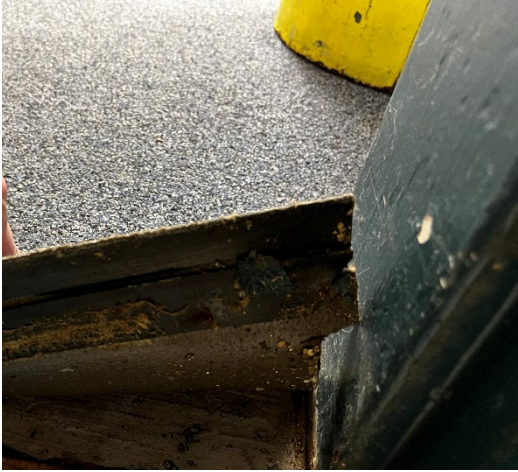
| | <p>1. HA 01-Non asbestos containing yellow carpet mastic.</p> |

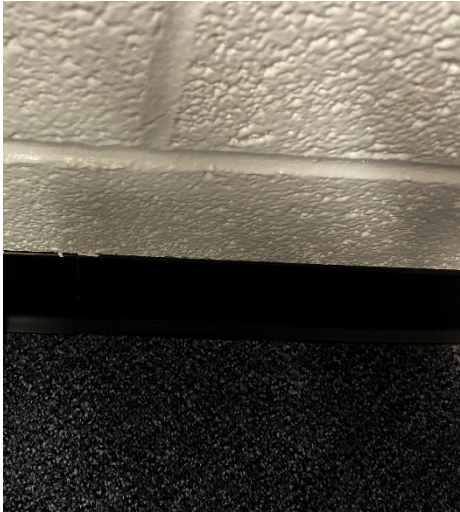
| | <p>2. HA 02-Non asbestos containing 4" black cove molding and associated mastic.</p> |

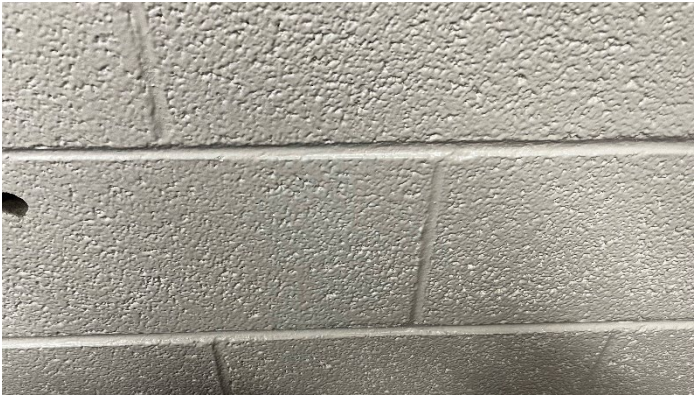
| | <p>3. HA 03-Non asbestos containing gray cinder block mortar.</p> |

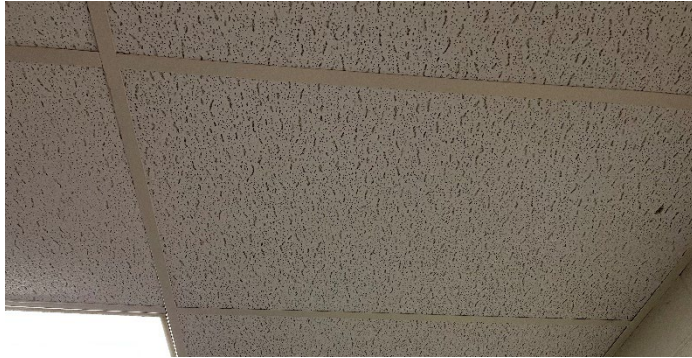
4. HA 04-Non asbestos containing white 2' x 4' lay-in ceiling tile with pin holes and waves.

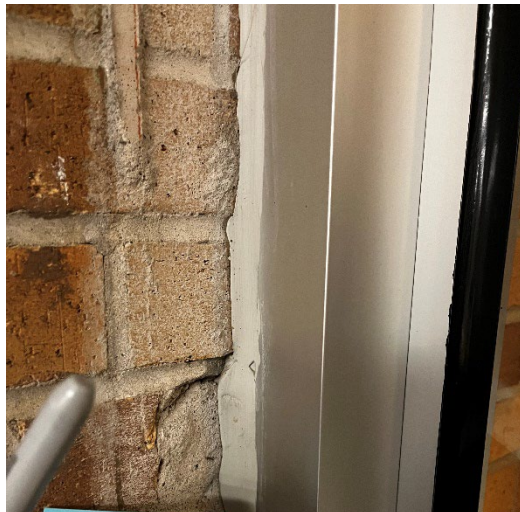
5. HA 05-Asbestos containing white window caulk.

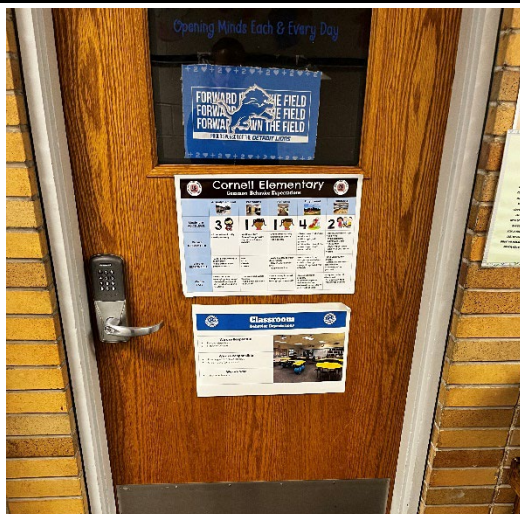
6. HA 06-Non asbestos containing wood door with safety glass.

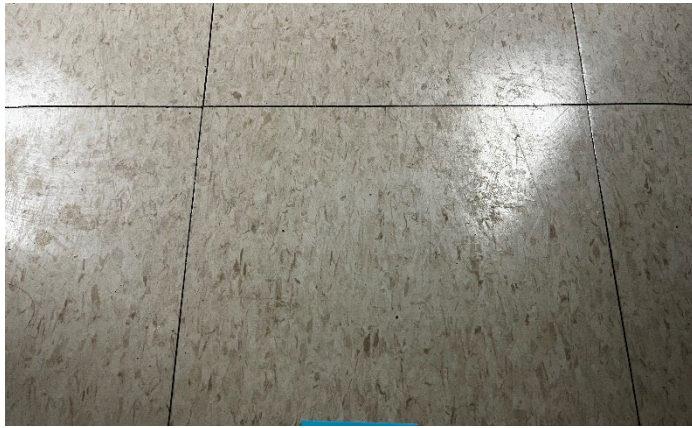
7. HA 07-Non asbestos containing cream 12" x 12" floor tile with brown and white streaks.

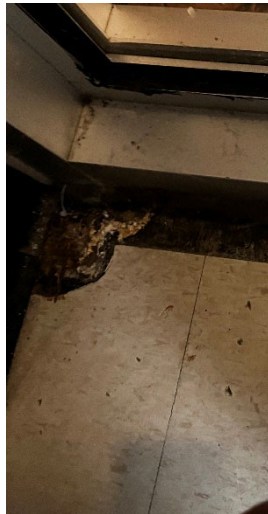
8. HA 08-Non asbestos containing yellow mastic associated with 12" x 12" floor tile.

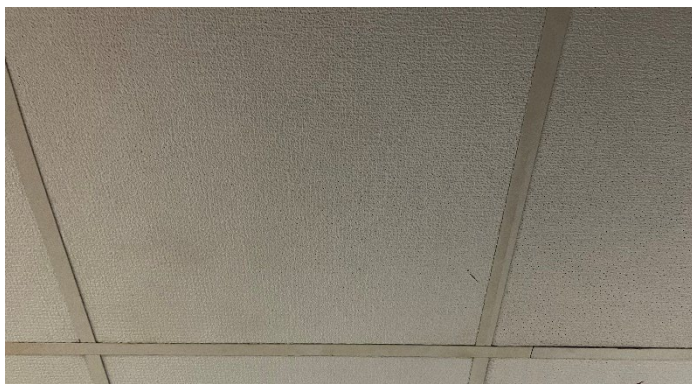
9. HA 09-Non asbestos containing white 2' x 4' lay in ceiling tile with fiberglass.

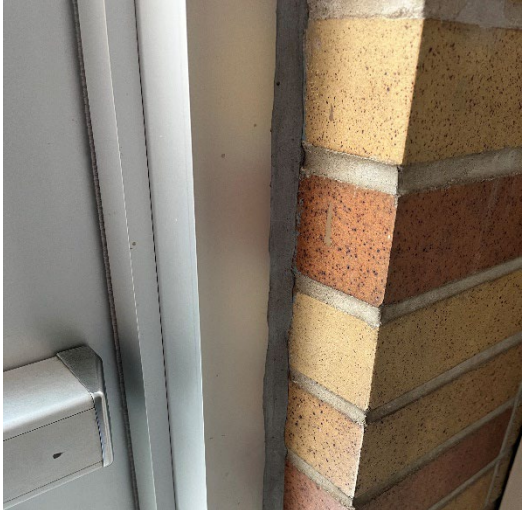
| | <p>10. HA 10-Non asbestos containing interior gray door and window caulk.</p> |

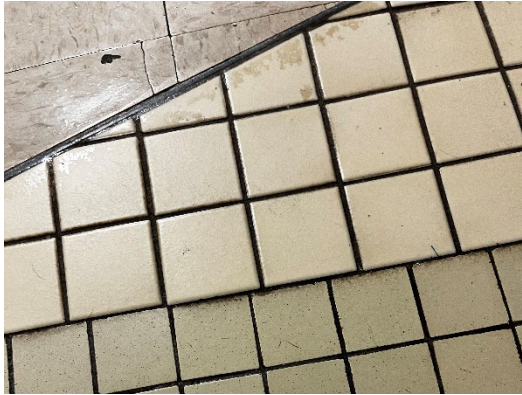
| | <p>11. HA 11-Non asbestos containing ceramic floor tile bedding compound and grout.</p> |

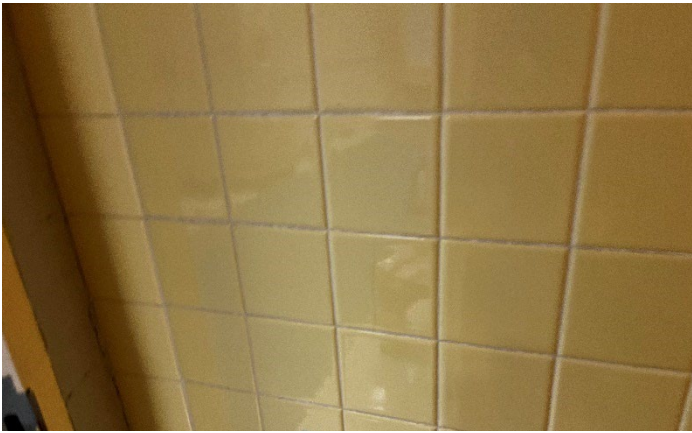
| | <p>12. HA 12-Non asbestos containing ceramic wall tile bedding compound and grout.</p> |

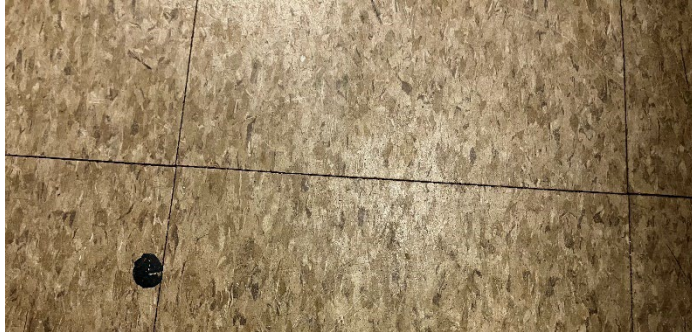
13. HA 13-Non asbestos containing light brown 12" x 12" floor tile with marble pattern.

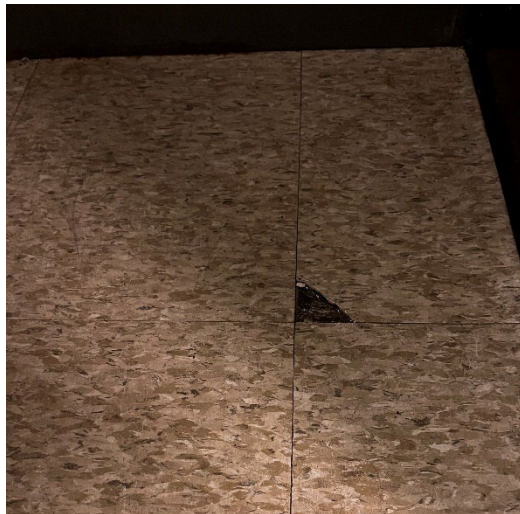
14. HA 14-Non asbestos containing black mastic associated with 12" x 12" floor tile.

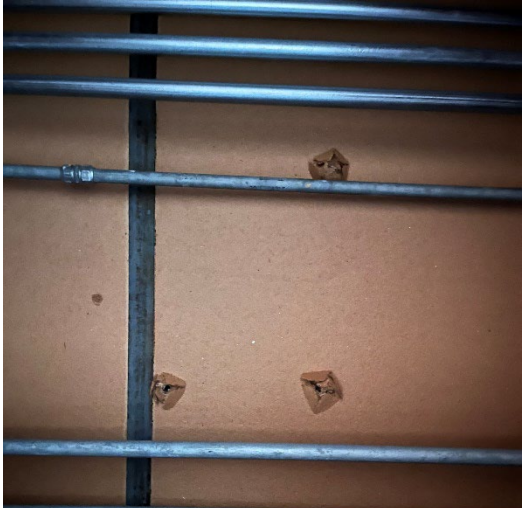
| | <p>16. HA 16-Non asbestos containing white gypsum decking.</p> |

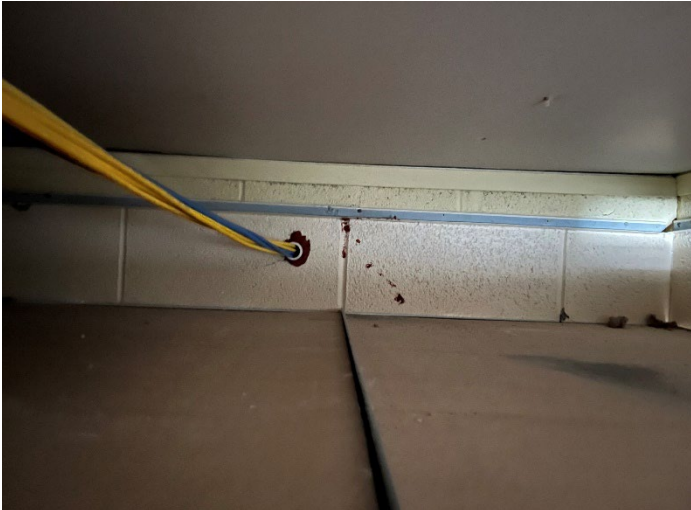
| | <p>17. HA 17-Non asbestos containing red fire stop caulk.</p> |

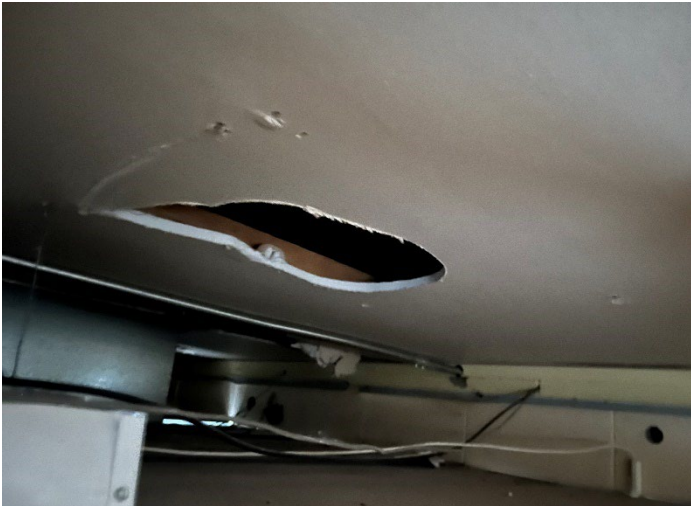
| | <p>18. HA 18-Asbestos containing white drywall joint compound on ceiling.</p> |

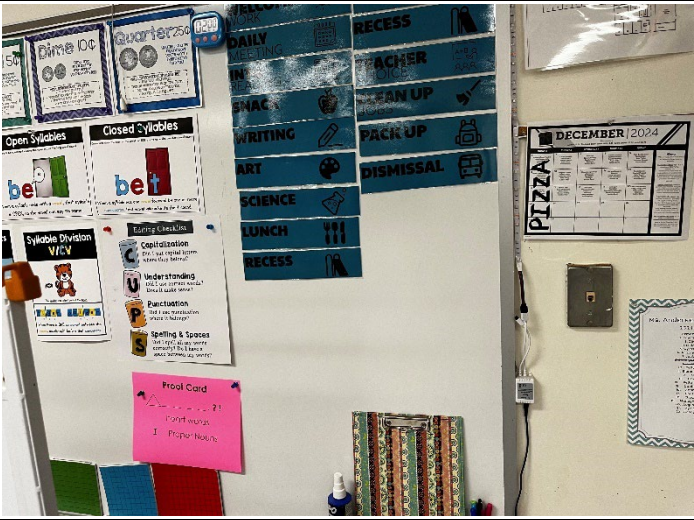
| | <p>19. HA 19-Non asbestos containing glue pods on bulletin boards,</p> |

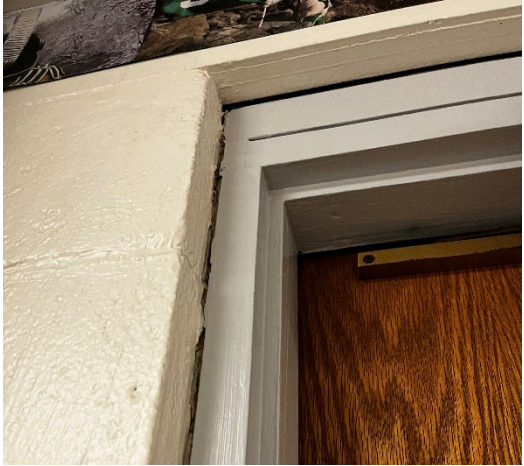
| | <p>20. HA 20-Asbestos containing interior brown door caulk.</p> |

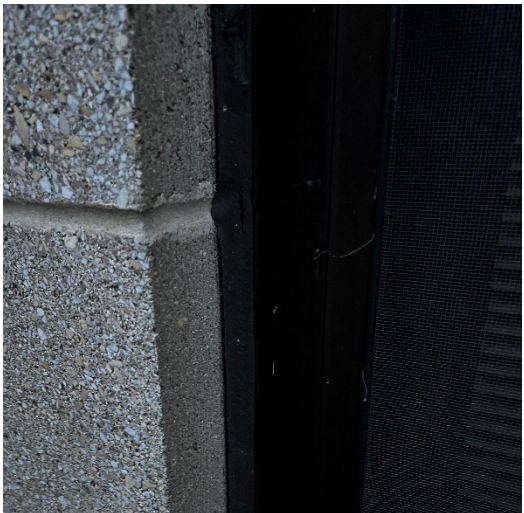
| | <p>21. HA 15-Non asbestos containing interior black window frame caulk.</p> |

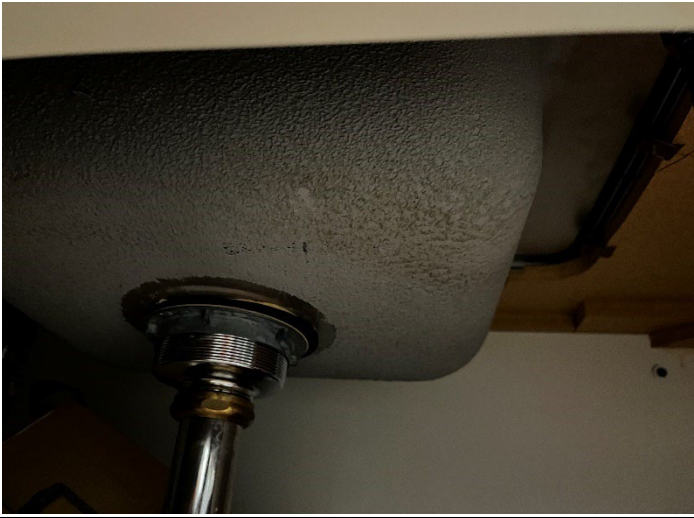
| | <p>22. HA 22-Non asbestos containing gray sink undercoating.</p> |

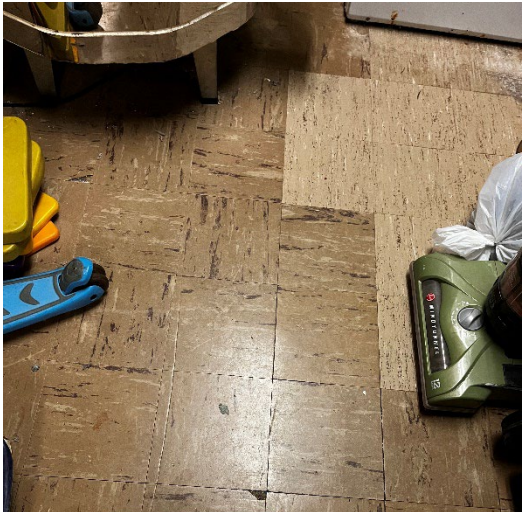
| | <p>23. HA 23-Asbestos containing brown 9" x 9" floor tile with brown streaks.</p> |

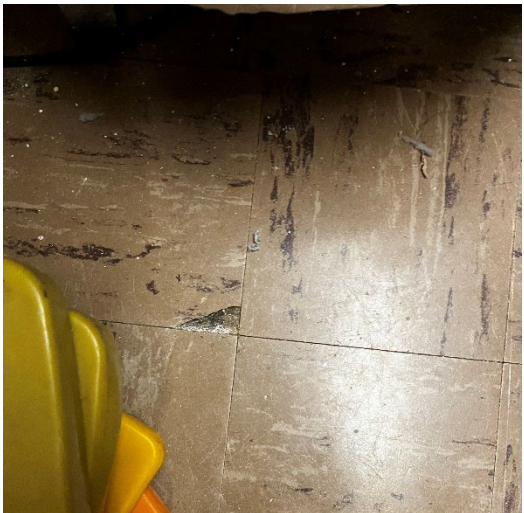
| | <p>24. HA 24-Non asbestos containing black mastic associated with 9" x 9" floor tile.</p> |

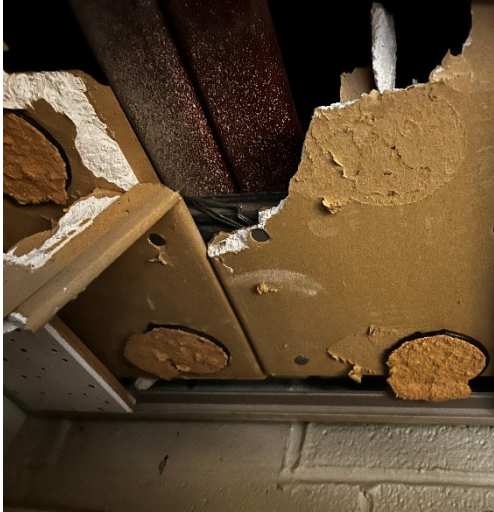
| | <p>25. HA 25-Non asbestos containing white drywall ceiling panels.</p> |

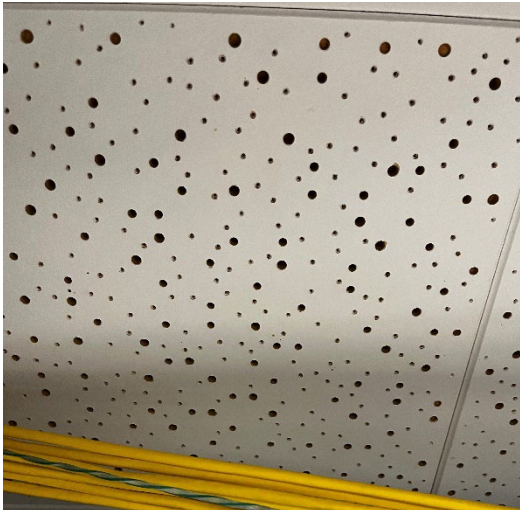
| | <p>26. HA 26-Non asbestos containing white 12" x 12" glued on ceiling tile with small and large holes.</p> |

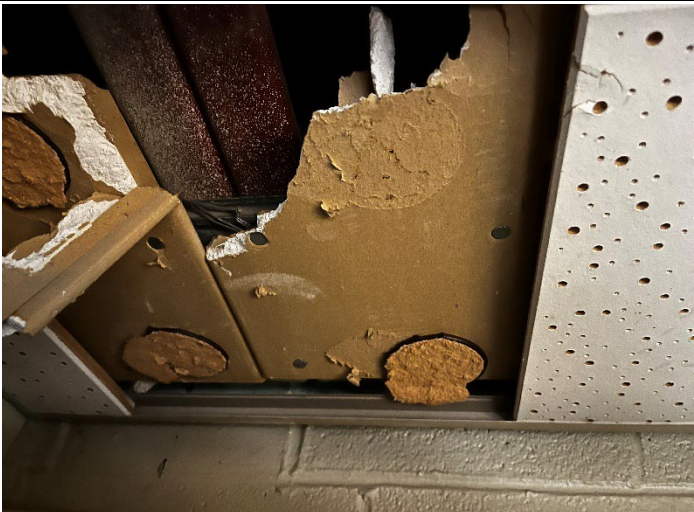
| | <p>27. HA 27-Non asbestos containing brown glue pods associated with 12" x 12" glued on ceiling tile.</p> |

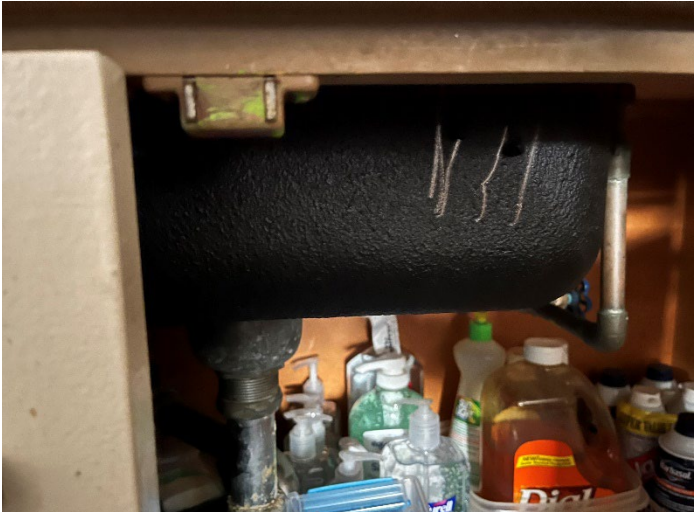
| | <p>29. HA 29-Asbestos containing black sink undercoating.</p> |

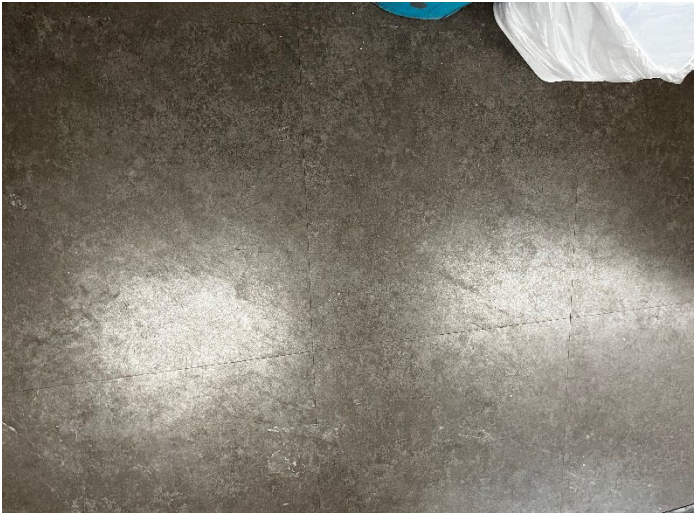
| | <p>30. HA 30-Non asbestos containing gray 2' x 2' linoleum and associated mastic.</p> |

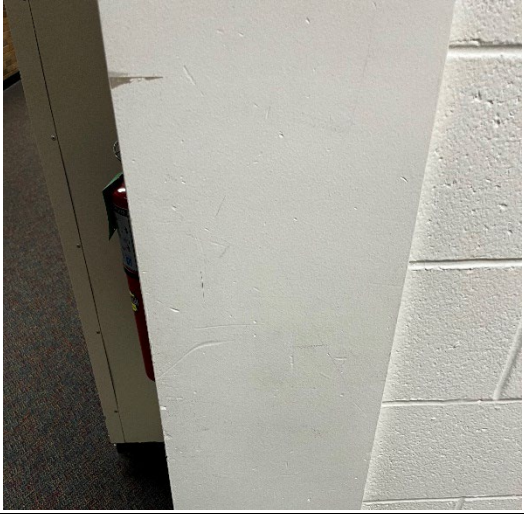
| A close-up photograph showing the corner of a white drywall wall. The wall is slightly textured and shows some minor imperfections. A dark carpeted floor is visible at the bottom left. | <p>31. HA 31-Non asbestos containing white drywall wall.</p> |

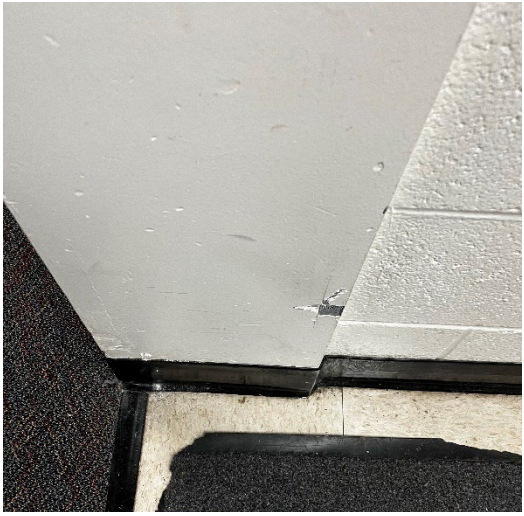
| A close-up photograph of a white drywall wall joint. The joint compound is visible, and the wall is slightly textured. A dark carpeted floor is visible at the bottom left. | <p>32. HA 32-Non asbestos containing white drywall joint compound on wall.</p> |

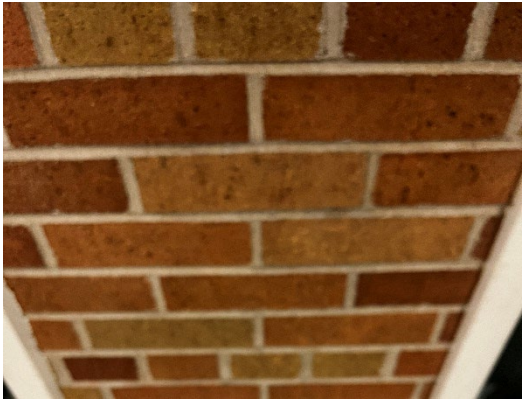
| A close-up photograph of a brick wall. The bricks are reddish-brown, and the mortar is a light gray color. The mortar is visible between the bricks. | <p>33. HA 33-Non asbestos containing gray brick mortar.</p> |

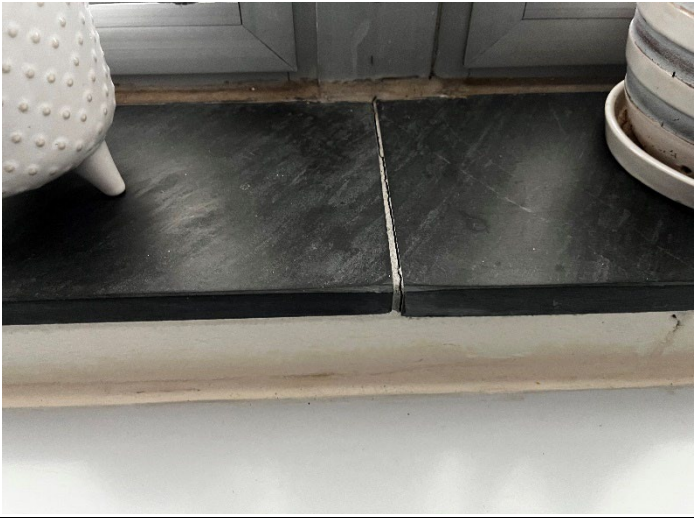
| | <p>34. HA 34-Non asbestos containing glue on windowsill.</p> |

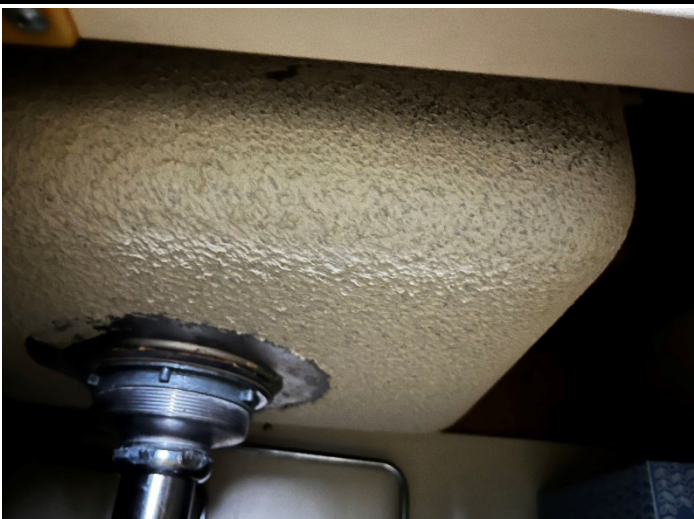
| | <p>35. HA 35-Non asbestos containing white sink undercoating.</p> |

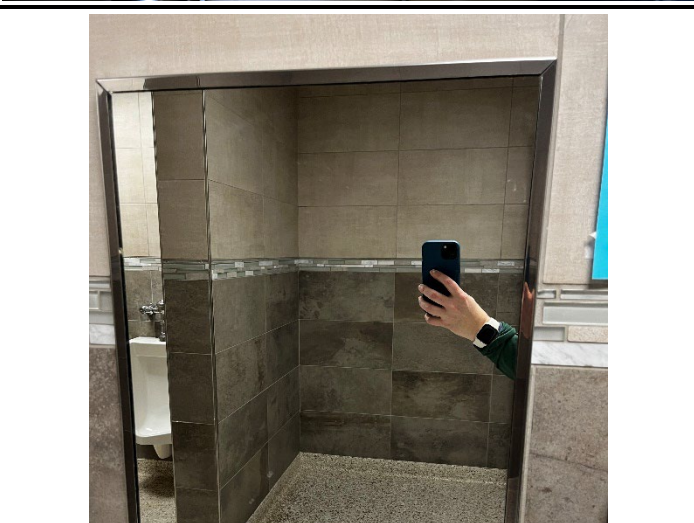
| | <p>36. HA 36-Assumed asbestos containing glue on mirrors.</p> |

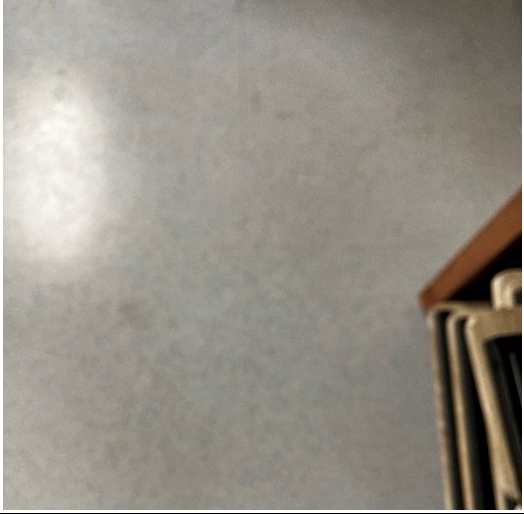
| | <p>37. HA 37-Non asbestos containing blue/gray 2' x 2' square linoleum and associated mastic.</p> |

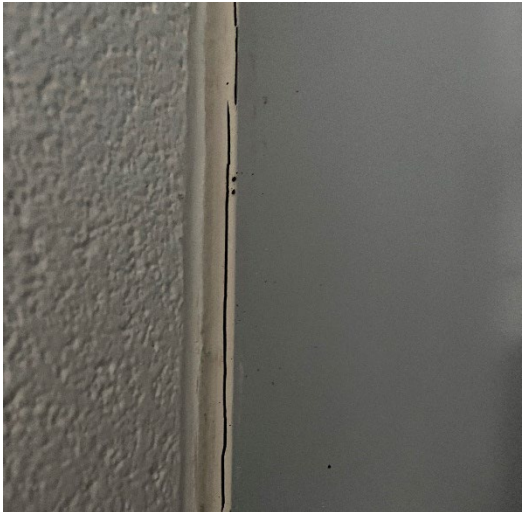
| | <p>38. HA 38-Non asbestos containing cream caulk on vent.</p> |

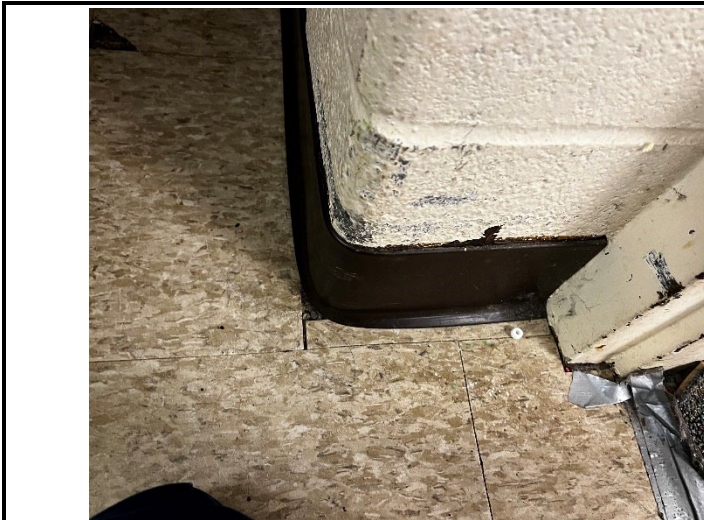
40. HA 40-Non asbestos containing 4" dark brown cove molding and associated mastic.

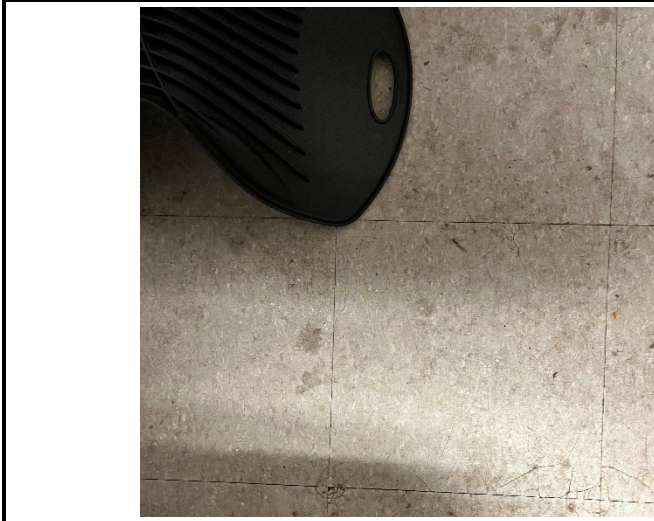
41. HA 41-Non asbestos containing gray 12" x 12" floor tile with marble pattern.

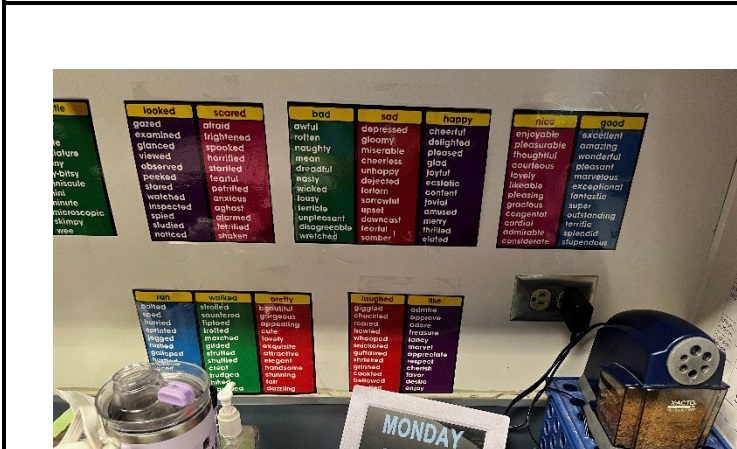
42. HA 42-Non asbestos containing glue on wainscoting.

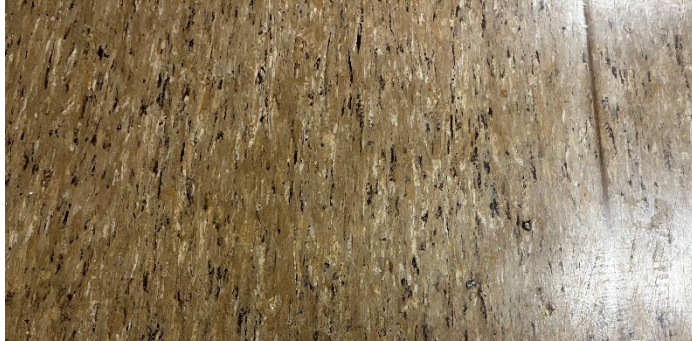
43. HA 43-Non asbestos containing tan linoleum with brown and white streaks and associated mastic.

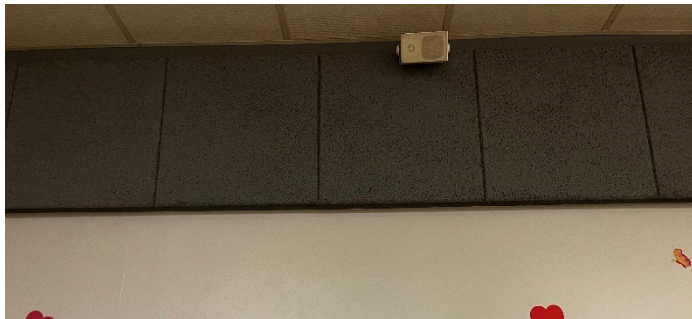
44. HA 44-Non asbestos containing brown sound boards.

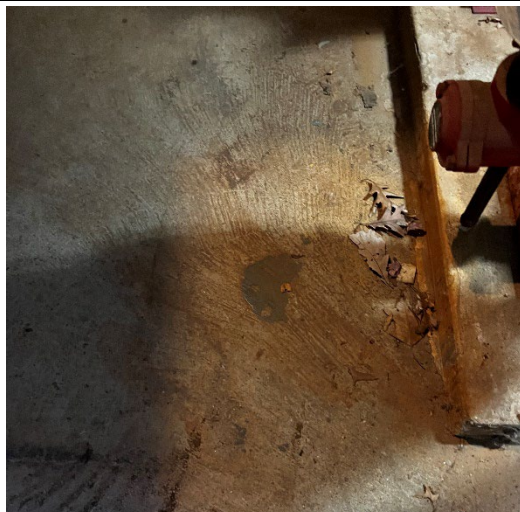
45. HA 45-Non asbestos containing gray concrete floor.

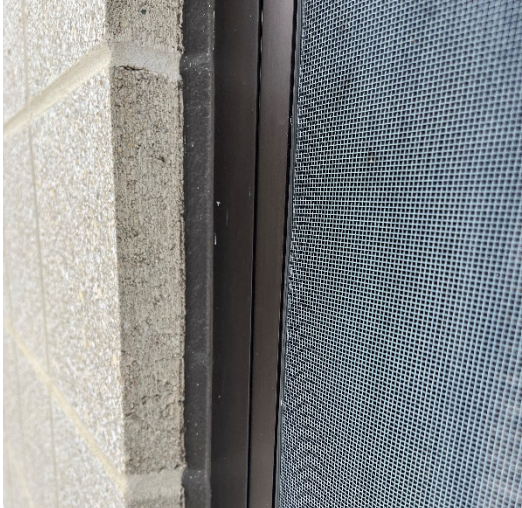
| | <p>46. HA 46-Non asbestos containing exterior dark brown window caulk.</p> |

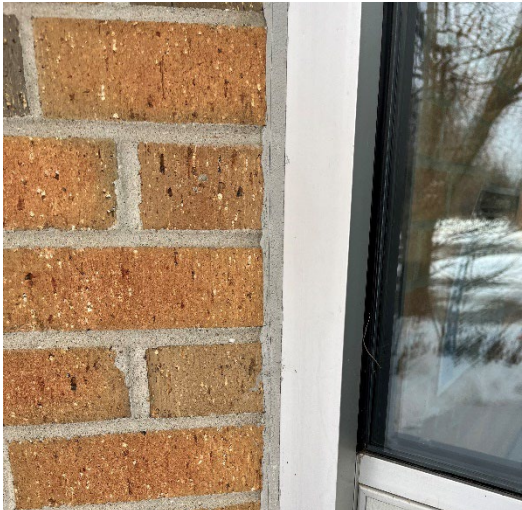
| | <p>47. HA 47-Non asbestos containing exterior gray door and window frame caulk.</p> |

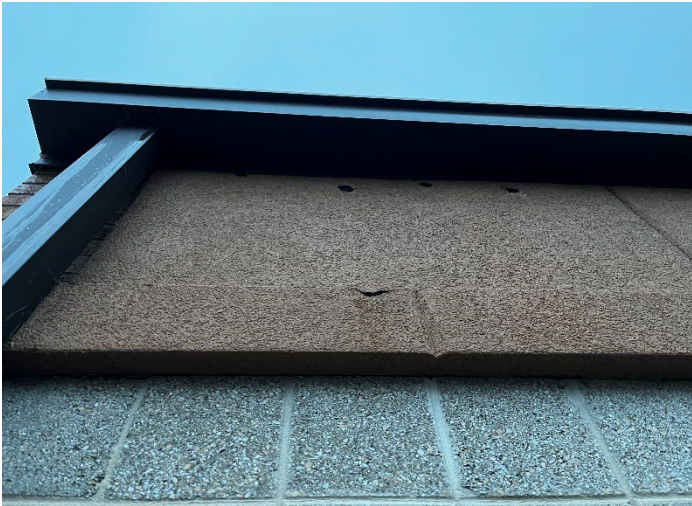
| | <p>48. HA 48-Non asbestos containing EFIS system.</p> |

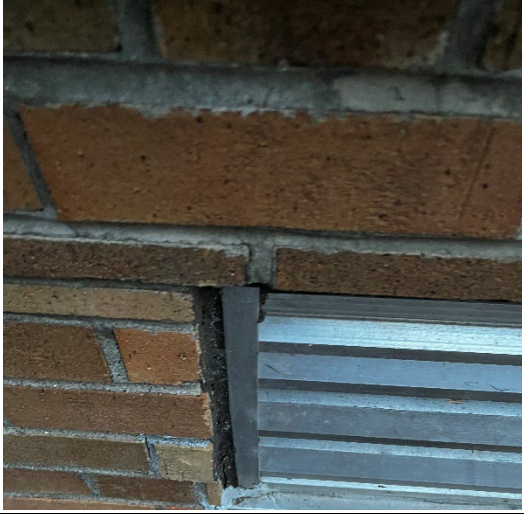
| | <p>49. HA 49-Non asbestos containing exterior dark gray vent caulk.</p> |

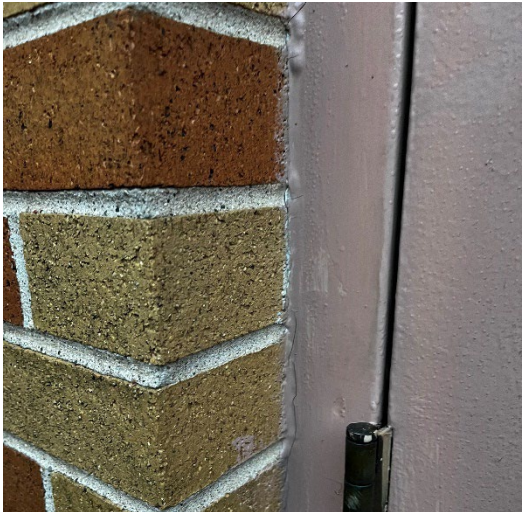
| | <p>50. HA 50-Non asbestos containing exterior white door frame caulk.</p> |

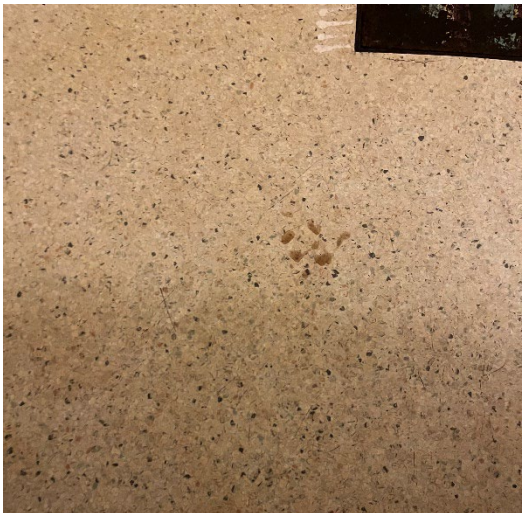
| | <p>51. HA 51-Non asbestos containing white linoleum with blue flecks and associated mastic.</p> |

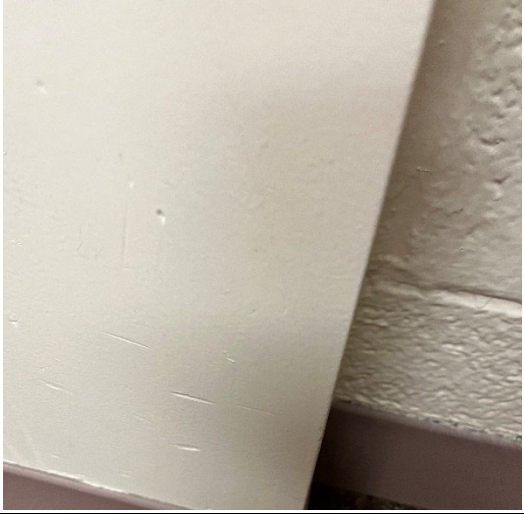
| | <p>52. HA 52-Non asbestos containing 4" tan cove molding and associated mastic.</p> |

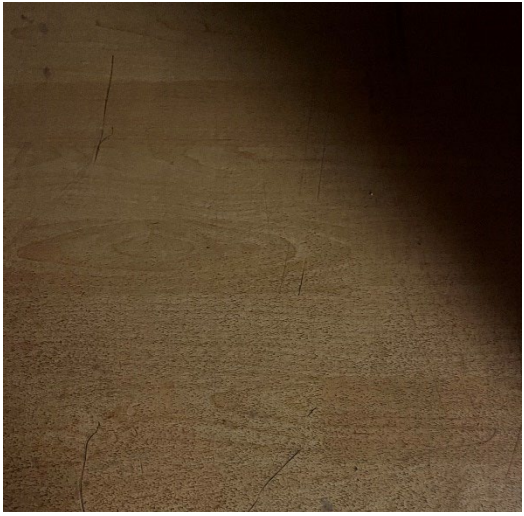
| | <p>53. HA 53-Non asbestos containing wood linoleum and associated mastic.</p> |

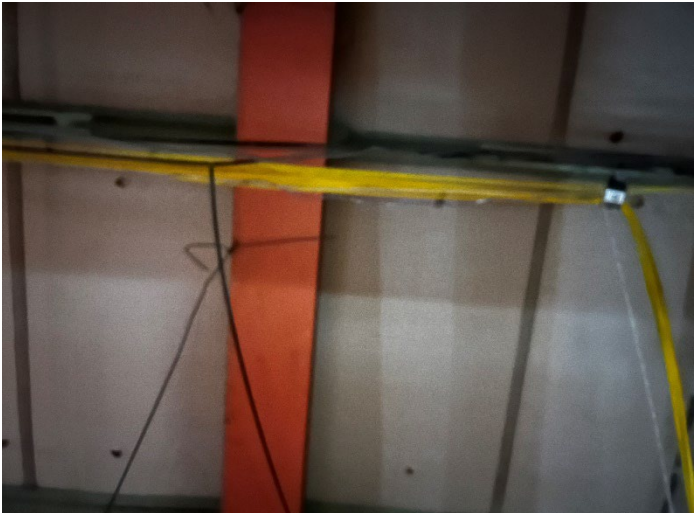
| | <p>54. HA 54-Non asbestos containing asbestos containing 5' x 5' white ceiling panels with holes.</p> |

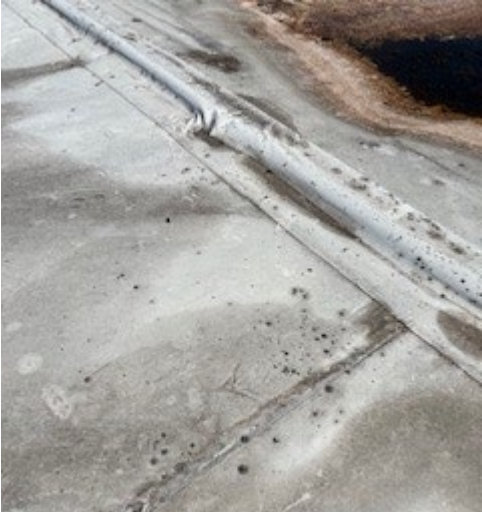
| | | <p>55. HA 55-Non asbestos containing rubber roof membrane.</p> |

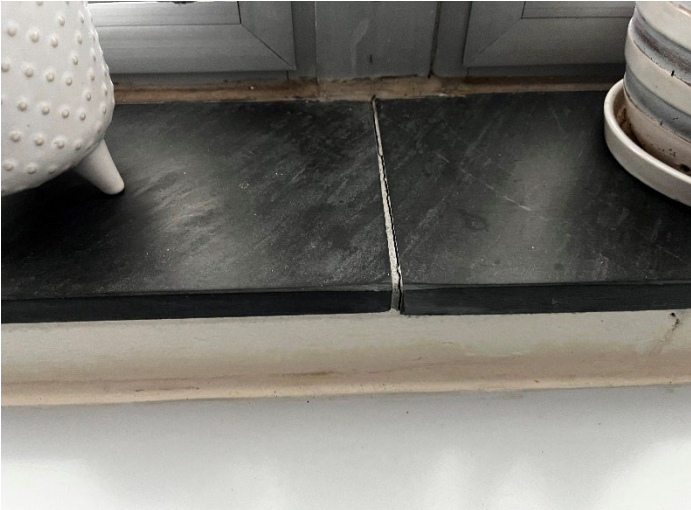
| | | <p>56. Non asbestos containing black slate windowsills.</p> |

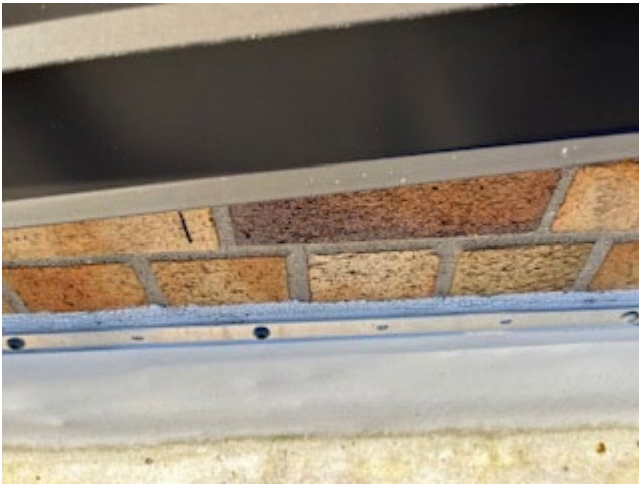
58. Non asbestos containing white roof caulk.

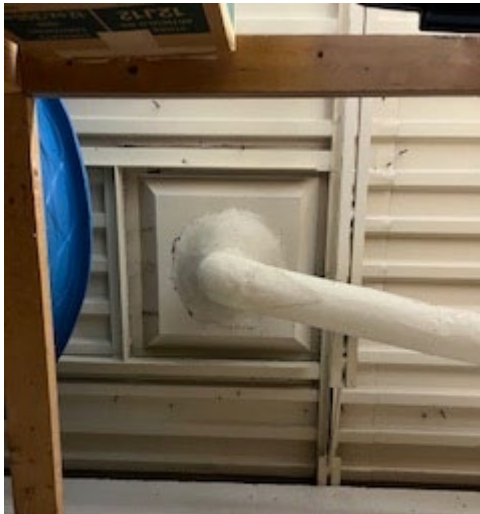
59. Non asbestos containing roof drain pipe joint insulation.
