## Environmental Resources Group

February 18, 2025

**RE: Limited Asbestos Sampling, Library  
Kinawa Middle School, 1900 Kinawa Road, Okemos, Michigan  
ERG Project No.: 240440**

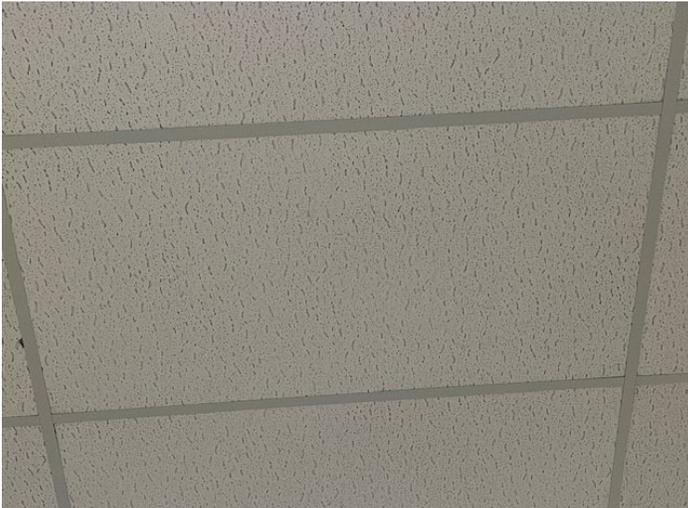
<p>1. HA-01-White, 2' x 4' drop ceiling tile with pits and fissures were present throughout the Library</p>

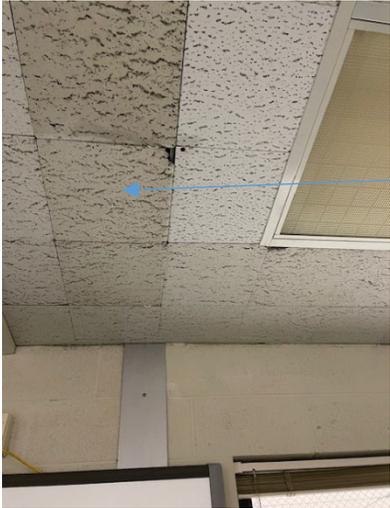
<p>2. HA-02-White (yellowing) 1' x 1' spline ceiling tile were present throughout the Library.</p>

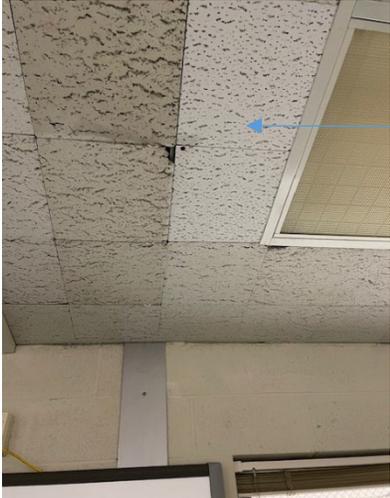
<p>3. HA-03-Bright white, 1' x 1' spline ceiling tile were present in the Library.</p>

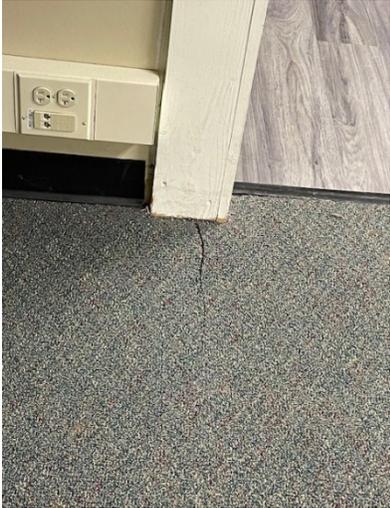
<p>4. HA-04 – Black, 4” tall cove molding and associated mastic were present throughout the Library.</p>

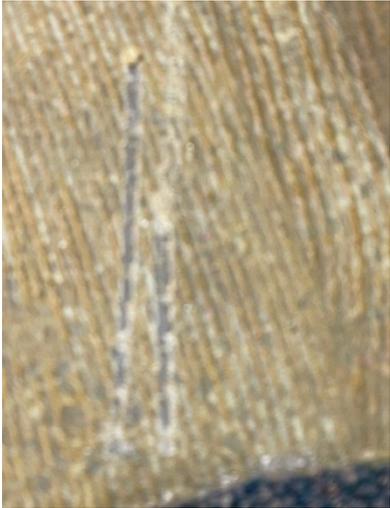
<p>5. HA-05-Brown carpet glue was found under the carpet throughout the Library.</p>
<p>No picture-see note</p>	<p>6. Please note that none of the above materials were found to contain asbestos.</p>
