INDOOR AIR QUALITY EVALUATION REPORT

OKEMOS HIGH SCHOOL KIVA
2800 JOLLY ROAD
OKEMOS, MICHIGAN 48864

ERG PROJECT NO.: 250759

PROJECT DATE: APRIL 9, 2025

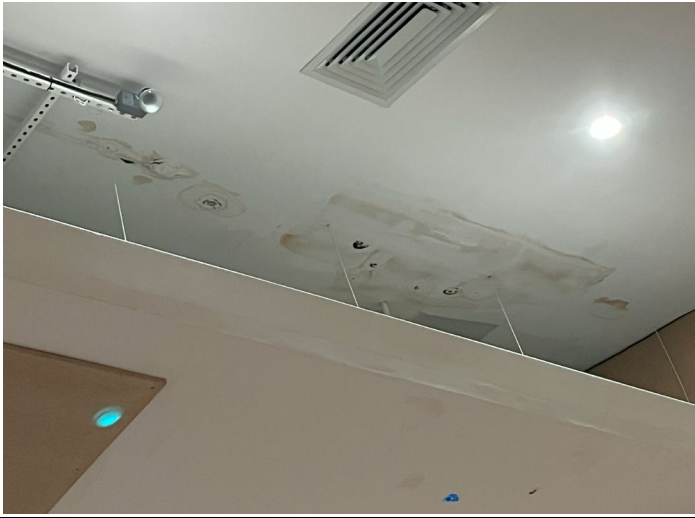
Water stained (ceiling, walls and carpet) and moldy building materials were found in the Kiva.

A photograph of a white ceiling with significant water staining and mold growth. A rectangular air vent is visible in the upper right, and a track lighting fixture is on the left. The ceiling surface is discolored with brown and black patches.	<p>1. Water stained and moldy ceiling was observed in the Kiva.</p>

- a. Remove and dispose of the mold damaged sections of the ceiling in the Kiva. Remove and dispose of any insulation in the wall cavities. Clean and disinfect cavities. Scaffolding and lifts will be required to reach the ceiling in the Kiva.

- b. Clean and disinfect the areas where the moldy ceiling was removed with a EPA registered cleaning agent. Allow the areas to dry.
3. Conduct a visual inspection in the work area in which no visible mold is found.

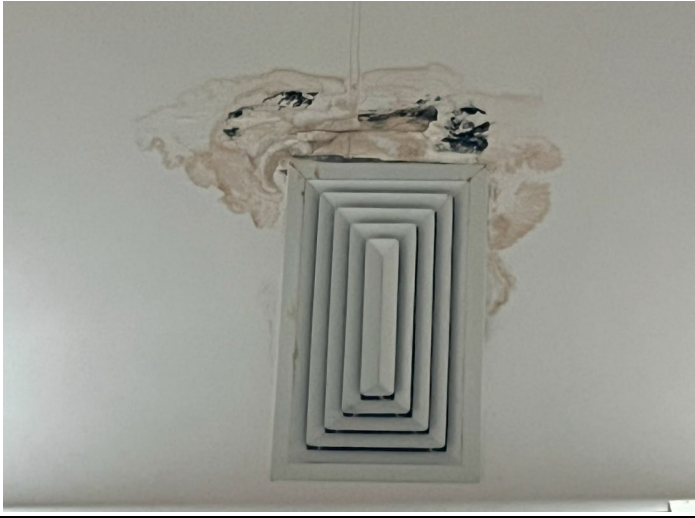
A close-up photograph of a rectangular air vent on a white ceiling. The vent is surrounded by a large, irregular area of mold and water staining, appearing as brown and black patches.	<p>2. Visible mold was observed around the vent in the Kiva.</p>

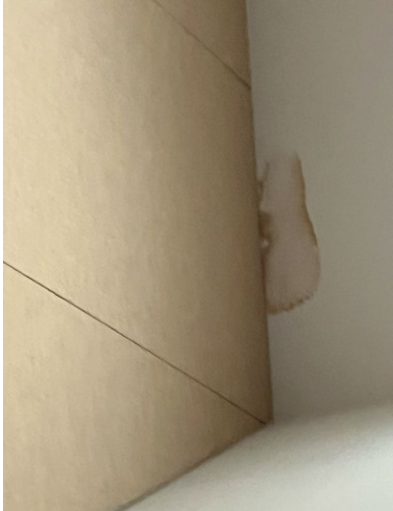
A photograph showing a corner of a room where a white ceiling meets a light-colored wall. There is a small, irregular water stain on the ceiling near the corner.	<p>3. Water stained ceiling was observed in the Kiva near the door.</p>

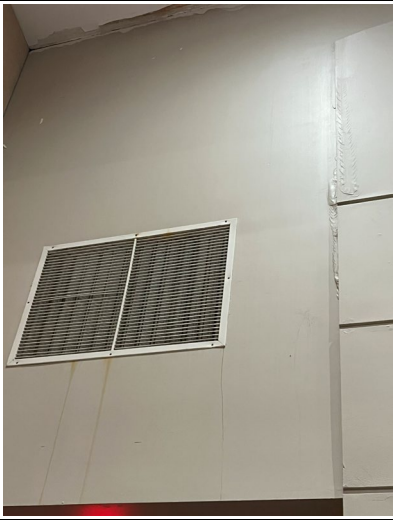
<p>4. Water stains and peeling paint was observed above the door.</p>

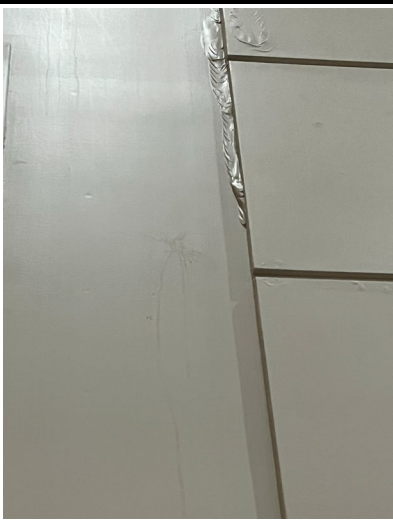
<p>5. Damaged paint was observed over the door way.</p>

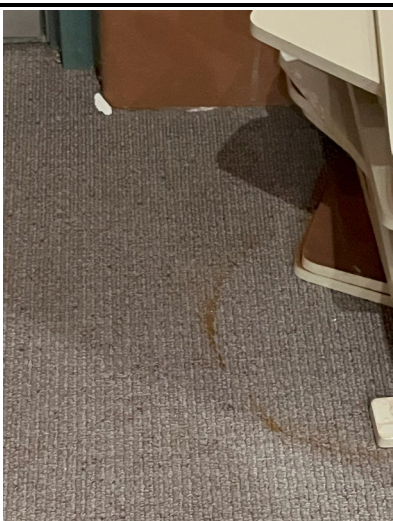
<p>6. Water stained carpet was observed upon entry to the Kiva.</p>

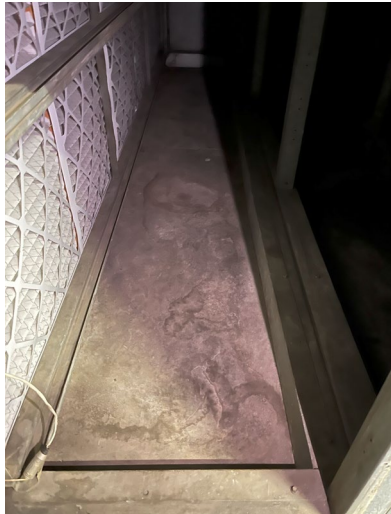
10. Picture inside the air handler that services the Kiva.

1. Ensure that the leak from the HVAC unit has been repaired.
2. Retain GFL Environmental to conduct the removal of mold and water-stained material from the Kiva. Ensure that GFL conducts the work consistent with the New York City Department of Health and Mental Hygiene Guidelines on Assessment and Remediation of Fungi in Indoor Environments, medium isolated areas and requirements and conduct the following:

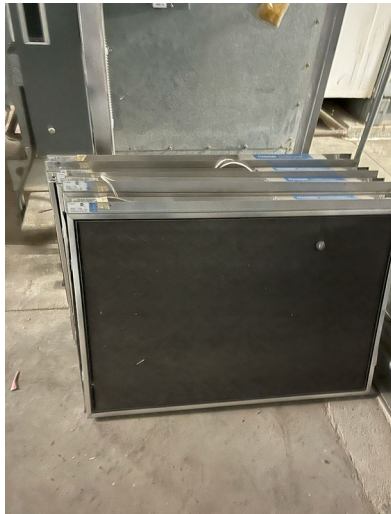
Maintenance staff reported that there was a leak from the Mechanical Room above the Kiva in which the dynamic air filters filled with water and caused water to infiltrate into the ceiling below. Maintenance staff

reported that the area was caulked to stop the water infiltration. The dynamic filters were believed to have been the source of water and they were replaced with pleated, wire back filters. No leaks have been reported since the filter change.

11. A picture of the dynamic air filter that was removed from the Air Handler.
