## INDOOR MOLD EVALUATION REPORT

**OKEMOS PUBLIC SCHOOLS  
CORNELL ELEMENTARY SCHOOL  
4371 CORNELL ROAD OKEMOS,  
MICHIGAN 48864**

**ERG PROJECT NO.: 250960  
PROJECT DATE: JULY 17 AND 21, 2025  
FINAL REPORT DATE: AUGUST 18, 2025**

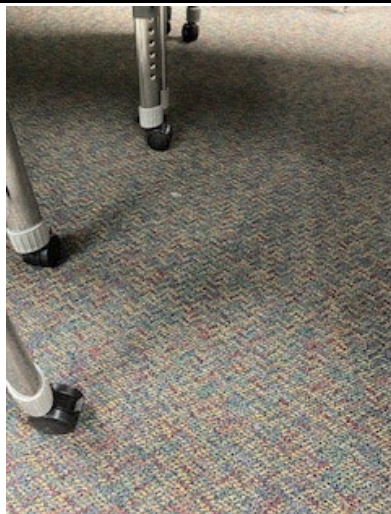
- No musty odors were observed immediately upon entry.
- A distinct coconut-like odor was observed upon entry.
- A large, scented candle was observed on the desk.
- No water marks or stains were observed.
- A patch of visible mold several square inches was observed on the carpet.
- The overall level of dust was low.

| Room #/ Designation | T | RH | CO2 | Floor Moisture | Comments |
|---|---|---|---|---|---|
| 26 | 72.6 | 75 | 417 | - | multiple small mold patches on carpet under tables. Candle observed. |

3. Although difficult to see in this image, small white patches of mold were observed under desks in Room 26.

6. Room 26 has a strong coconut fragrance, presumably from the large, scented candle on the desk. Please remove the candle and refrain from bringing that or other strong fragrances into the building.

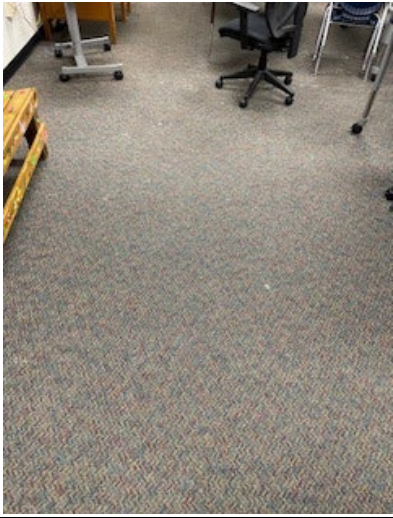
| Room #/ Designation | T | RH | CO2 | Floor Moisture | Comments |
|---|---|---|---|---|---|
| 25 | 73.7 | 72.5 | 460 | 25 (red) | multiple small mold patches on carpet |

| | <p>4. White patches of mold were visible on the carpet in Room 25, mostly in a swath between the classroom door and Teacher's desk.</p> |

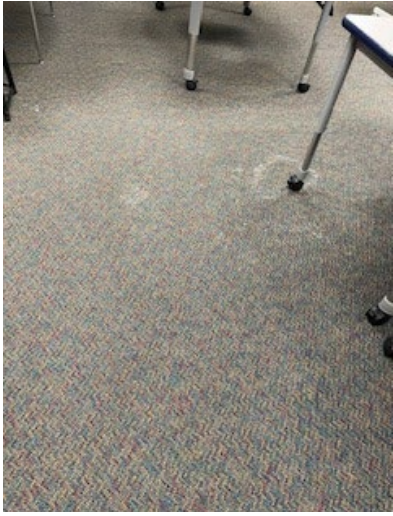
| Room #/ Designation | T | RH | CO2 | Floor Moisture | Comments |
|---|---|---|---|---|---|
| 24 | 72.8 | 74 | 422 | 30 (red) | mold patches on carpet, room smells musty, door is potentially swollen |

| | <p>5. Visible mold was observed on the carpet in Room 24</p> |

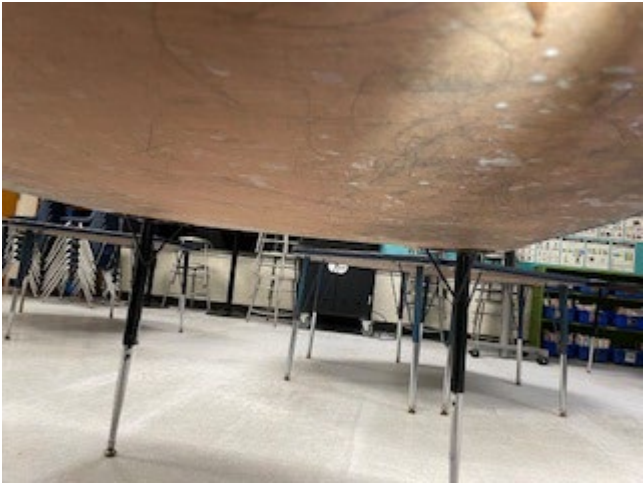
- A distinctive odor of mold was observed immediately upon entry.
- No water marks or stains were observed.
- No carpet was present in the room.
- The floor surface was slightly slippery (due to condensation).
- Visible mold was observed on the underside of desks throughout the room. The mold did not appear to have been disturbed as might be the case with children's legs rubbing the underside of the tables.
- The overall level of dust was low.

- The results of tape lift sample analysis indicated the dust under the tables in the Staff Lounge was normal dust consisting of less than 1% mold. The test data from the underside of the tables in Room 14 indicated the clear presence of *Aspergillus/Penicillium* (90% mold).

The tape lift sample from the Staff Lounge is considered normal dust and was found to contain fewer than 1% mold spores and none was of an allergenic or highly allergenic variety. The tape lift sample from Room 14 indicated that mold of the genera *Aspergillus*/*Penicillium* were present on the underside of tables in the room.

| Room #/ Designation | T | RH | CO2 | Floor Moisture | Comments |
|---|---|---|---|---|---|
| 14 | 77.9 | 63.5 | 444 | 30+ (red) | no carpet, musty smell in room, mold on underside of tables, no pattern of disturbance |

| | <p>6. Room 14 has no carpet, but the underside of classroom tables were visibly moldy. The mold did <b>not</b> appear to be disturbed as might occur when the tops of student legs hit the underside of the table.</p> |

4. For Room 14, retain GFL Environmental to conduct cleaning and disinfection of the underside of the tables throughout the classroom. Conduct this work with a negative air machine exhausting to out-of-doors. Once tables are cleaned and disinfected or sanitized, surfaces (floors, window ledges, etc.) may be cleaned by HEPA vacuuming or wet wiping with a disinfecting solution. If odors persist after cleaning and dehumidification, ozone treatment may be necessary.

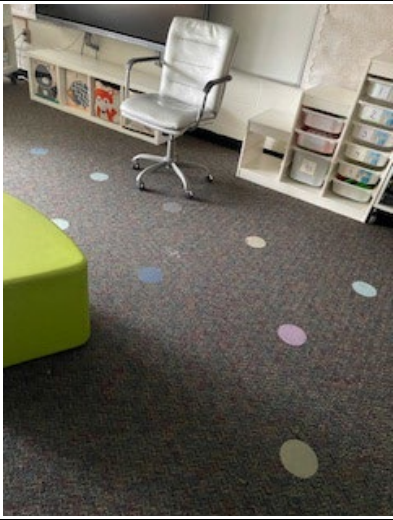
| Room #/ Designation | T | RH | CO2 | Floor Moisture | Comments |
|---|---|---|---|---|---|
| 11 | - | - | - | 30+ (red) | multiple small mold patches on carpet, dehumifier present |

| | | <p>7. Small white patches of visible mold were observed on the carpet in Room 11.</p> |

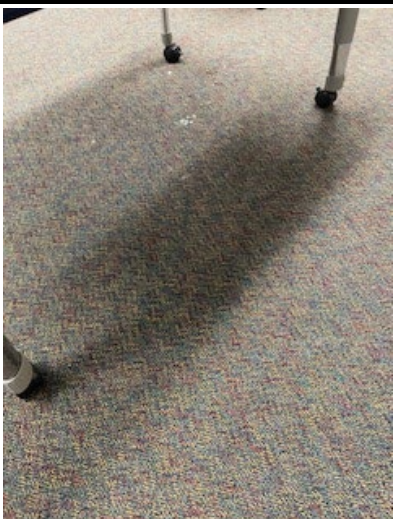
| Room #/ Designation | T | RH | CO2 | Floor Moisture | Comments |
|---|---|---|---|---|---|
| 16 | 72.6 | 57.2 | 415 | 0 | multiple small mold patches on carpet |

| | | <p>8. Visible patches of mold were present under one of the tables in Room 16.</p> |

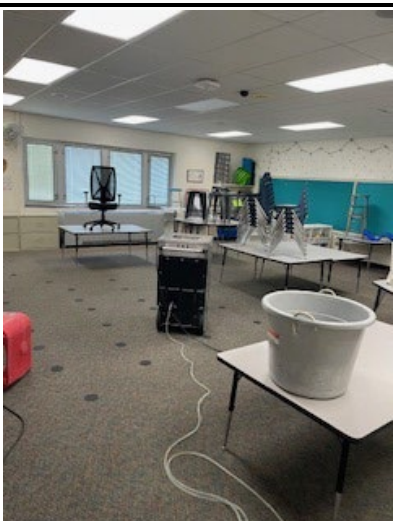
- Indoor relative humidity was recorded between 63 and 75.5 percent on July 17, 2025. . Out-of-doors relative humidity was 73 percent. During the July 21 site visit, relative humidity in Room 15, which had been cleaned and was in the process of being dehumidified, was 38.5 percent

| Room #/ Designation | T | RH | CO2 | Floor Moisture | Comments |
|---|---|---|---|---|---|
| 15 | 73 | 38.5 | 464 | 0 | carpet cleaned and dehumidifier in operation (7/21/25) |

| | | <p>9. On July 21, Room 15 was observed to have clean carpet and a commercial dehumidifier and high velocity fan were in operation. Relative humidity in this room was 38.5%. No odors were present, the carpet appeared clean and no visible mold was observed.</p> |
