REMAINING MOLD EVALUATION REPORT

KINAWA MIDDLE SCHOOL
1900 KINAWA DRIVE
OKEMOS, MICHIGAN 48864

ERG PROJECT NO.: 250993

FINAL REPORT DATE: AUGUST 13, 2025

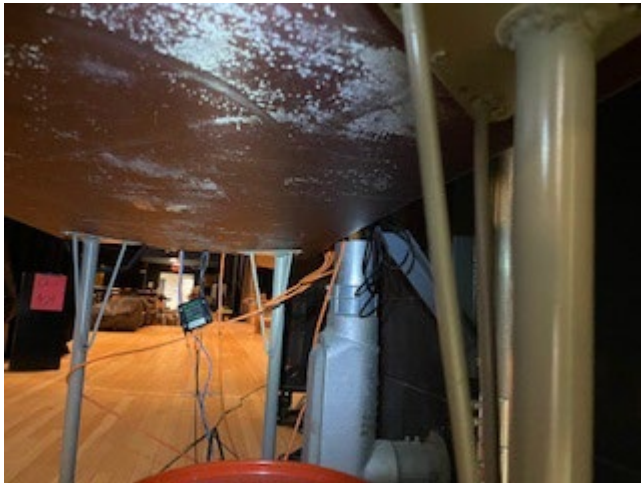
- No musty or earthy odors were detected upon entry to the Auditorium.
- No visible mold was observed on seats or seat backs.
- No visible mold was observed on instruments, instrument cases or instrument racks in the Auditorium or on the Stage.
- The HVAC system servicing this area was shut down for maintenance or repair.
- 6 square feet of visible mold was observed on the bottom of a table at the ELECTRO CONTROLS cabinet on the Stage.
- The overall level of the dust was low.

1. Visible mold was observed under a table on the Auditorium Stage near the ELECTRO CONTROL panel.

Stage (the ease with which the mold table can be removed and discarded make it next on the priority list).

- d. Clean and disinfect moldy tables, chairs, cabinets, bookcases, shelves and other furniture or surfaces. Clean and disinfect any visibly moldy walls.
3. In the Pool and Pool Mechanical Room, conduct the following:
- a. Ensure the ventilation system remains operational and in exhaust mode.
 - b. Remove by the most direct route out of the building and discard low value moldy items (tables, file cabinets, boxes). Clean high value items (tools, equipment, parts).
 - c. Remove moldy pipe insulation in the Pool Mechanical Room, clean and disinfect surfaces, apply a long acting biocidal agent.
 - d. Remove the drywall debris and repair the damaged drywall above the stairs to the Pool Mechanical Room.
4. On the Auditorium Stage, conduct the following;
- a. By the most direct route possible, remove the moldy table on the Stage and discard it in the trash.

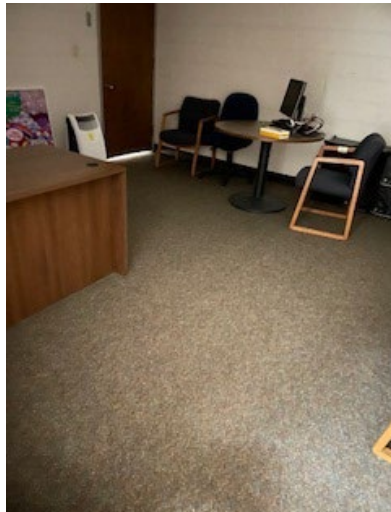
- No musty or earthy odors were detected upon entry.
- No visible mold was observed.
- Carpet was present in the room.
- The ceiling tile appeared to be original to the room.
- The overall level of dust was low to moderate.

2. Room 401 has original carpet, but no visible mold or musty odors were detected in the room.

In Room 401 or any location where carpet may require removal, conduct the following:

- k. Remove cove molding and scrape the mastic flat to the wall surface in preparation of new cove molding installation (by others).
 - l. Where carpet removal is necessary, carefully inspect the area below the carpet for asbestos containing floor tile. Moisten and then remove the carpet within the confines of a critical barrier enclosure. Only when no tile (if present) adheres to the carpet, may the carpet be discarded as non-ACM waste. Ensure appropriate asbestos barrier tape and warning signs are in place if asbestos containing floor tile are present. Ensure a drop cloth decontamination station is constructed with a dedicated HEPA vacuum for the decontamination of waste, tools and personnel.

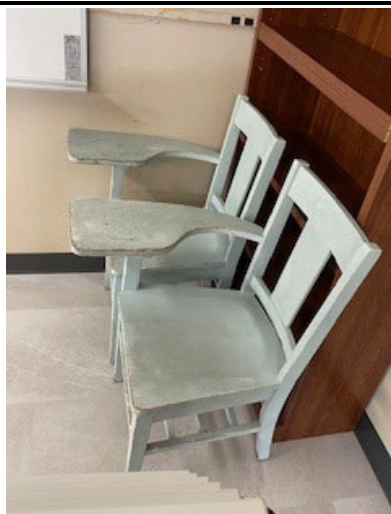
- No musty or earthy odors were detected upon entry into this room.
- Two non-district issued wooden chairs were observed in the room. They appeared to have had the paint “stressed” to artificially age the chairs.
- No air freshener was observed in the room.
- No visible mold was observed in the room.
- The overall level of dust was low.

3. A pair of wooden chairs were observed in Room 410. The paint appears to be "distressed".

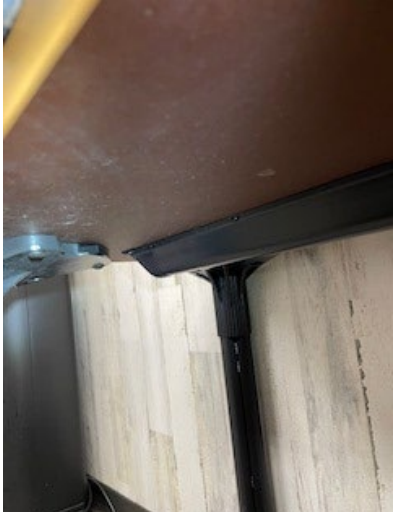
- No musty or earthy odors were detected upon entry to the classroom.
- No musty or earthy odor was detected upon entry to the Fish Tank Access Room.
- Visible mold was observed on the bottom of a pair of desks, on wood cabinets, on an overturned bin and other surfaces.
- Approximately 240 square feet of visible mold was observed on the walls and doors of the Fish Tank Access Room.
- No visible mold was observed on the contents of or within the wood or metal cabinets.
- 6 water stained drop ceiling tile were observed.
- The drop ceiling tile gridwork was rusted.
- The corner beads on the drywall were rusted.
- The return air grilles appeared clean and unobstructed.
- The supply air grilles appeared clean and unobstructed.
- The overall level of dust was low.

A close-up photograph showing the underside of a dark brown wooden table. A black metal support leg is visible, and a light-colored, fuzzy mold is growing on the wooden surface near the leg.	<p>4. Visible mold was observed under tables in Room 308.</p>

Room 308 (as students will soon be returning to this room for the school year, ERG believes this room should get the highest priority).

1. Retain a professional mold remediation contractor (GFL Environmental) who shall complete the following in Room 308 (including the fish tank access room) the three offices behind Room 308, the Electrical Room, Clinic and the Math Book Storage Room:

- d. Clean and disinfect moldy tables, chairs, cabinets, bookcases, shelves and other furniture. Clean and disinfect visibly moldy walls. Discard (with prior notification to Okemos Public Schools-Operations Department) items that cannot be properly or thoroughly decontaminated (i.e.- the Clinic sick bed).

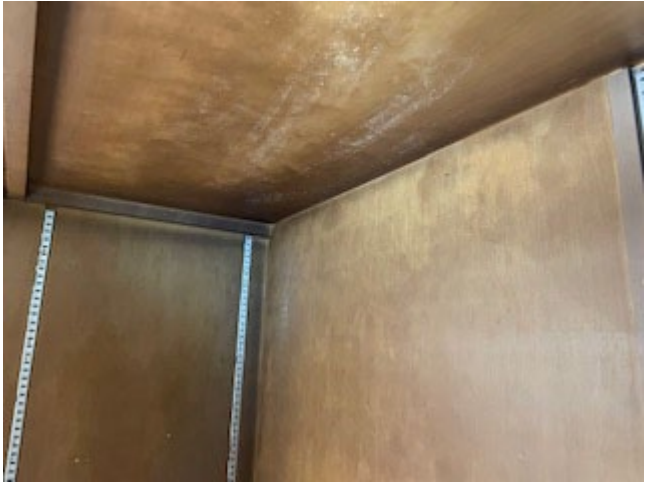
- No musty or earthy odors were detected upon entry to this area.
- Approximately 40 square feet of mold was reported behind the wall covering in the offices.
- Approximately 6 square feet of visible mold was observed on book shelves in the Work and Copy Rooms.
- Approximately 8 square feet of visible mold was observed under tables in the Staff Work Room.
- The overall level of dust was low.

A photograph of a wooden bookshelf. The top edge of the shelf is visible, and a white, fuzzy mold is growing along the bottom of this top edge. A metal support bracket is visible on the left side.	<p>5. Visible mold was observed on the bottom of the top of the bookshelf in the Copy Room.</p>
  A photograph of a wooden door. A white, fuzzy mold is growing on the surface of the door. A small, dark, diamond-shaped object is visible on the floor in the background.	<p>6. Visible mold was observed on the wood door in the vicinity of the Staff Work Room (near Room 308)</p>

Rooms behind 308 (including the Staff Work Room and Copy Room, these rooms are frequented by staff and should be the next priority).

2. In the Main Office, Guidance Office, Mail Room, Staff Work Room and Copy Room, conduct the following:
- a. Shut off or isolate the Heating, Ventilating and Air Conditioning System serving the rooms where the work will occur. Install critical barriers over all HVAC grilles, grates, diffusers, etc.

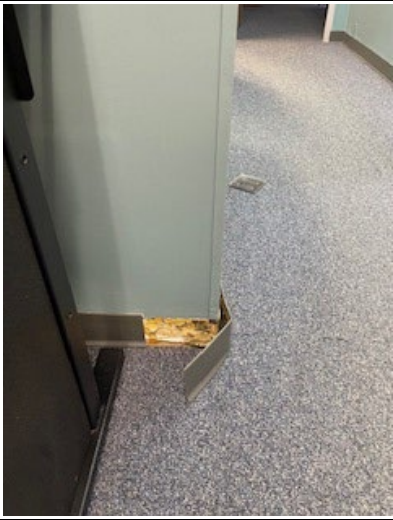
- No musty or earthy odors were observed upon entry to these offices.
- Approximately 3 square feet of visible mold was observed on the bookshelf in Mrs. Maness' office.
- Damaged/delaminated cove molding was observed in the Guidance Office. Multiple colors of adhesive were observed on the wall at this location. No mold was observed, no water marks were observed and the drywall was firm (not soft as occurs over several periods of wetting and drying).
- Approximately 7 square feet of visible mold was observed on Mail Room cupboard doors.

<p>7. Damaged cove molding was observed in the Guidance Office. Multiple colors of adhesive were observed, but no odors, water marks or visible mold were observed.</p>

Clinic/Mail Room – ERG believes the visible mold in the Clinic and Mail Room make these rooms priorities over the Guidance Office and Main Office. Previous testing in this area revealed that drywall joint compound was asbestos containing material. GFL must exercise caution and follow applicable regulations when contacting and disturbing ACM. ERG recommends on-site third party air sampling during and after any work that disturbs ACM (i.e.- as may occur during cove molding repair).

Main and Guidance Offices – Staff frequent this area.

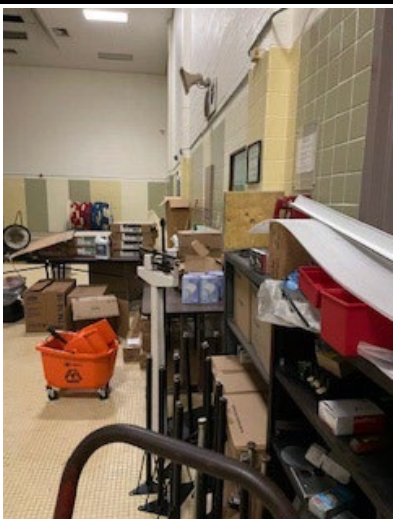
<p>8. The Pool Room has a wide variety of stored materials.</p>

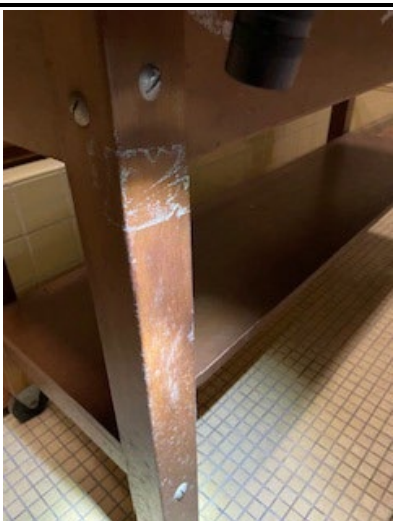
- No musty or earthy odors were detected upon entry to the Pool Room.
- Visible mold was observed on the bottom of a desk, on metal cabinets, on the bulletin board and on some cardboard boxes.
- Visible mold was observed on some objects in the Storage Room containing the yellow rubber ducks.
- 10 square feet of visible mold was observed in the Tool Storage Room.
- A significantly damaged section of ceramic tile was observed.
- The Pool Mechanical Room smelled moldy upon entry.
- Approximately 60 linear feet of fiberglass pipe insulation in the Pool Mechanical Room was moldy.
- Water from an unknown source could be heard dripping at the far end of the room.
- The uninsulated pipe was rusted.
- Damaged drywall was observed above the stairs to the Pool Mechanical Room.
- The overall level of dust was moderate to high.

<p>9. Among the stored items in the Pool Room are moldy wooden tables.</p>

Pool and Pool Mechanical Room- These rooms are isolated by a ventilation system that is operated in 100% exhaust mode. Very few staff and no students access this area allowing it to have the lowest priority.

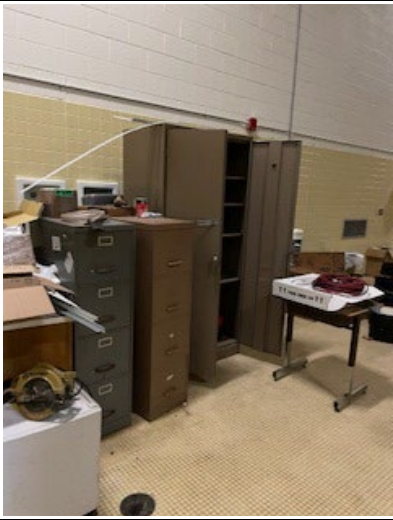
<p>10. Moldy tables, moldy metal file cabinets and moldy cardboard boxes were staged for disposal in the Pool Room.</p>

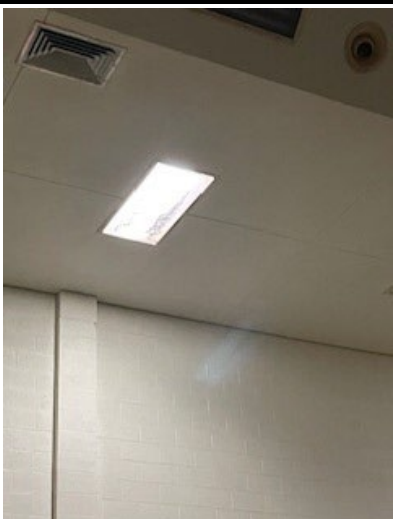
<p>11. Fluorescent light fixture lenses trapped dirt and debris and some appear to have held water in the past.</p>

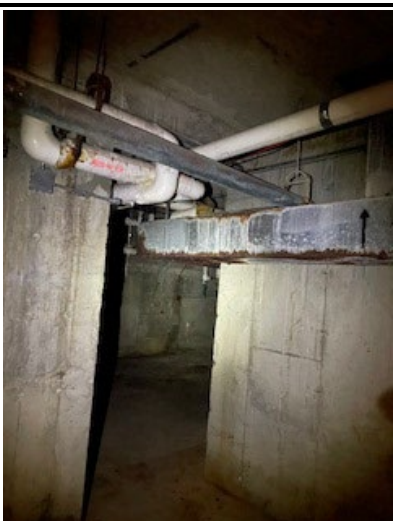
<p>12. Moldy pipe insulation and rusted ducts were observed in the Pool Mechanical Room. This room also had a distinct musty odor.</p>

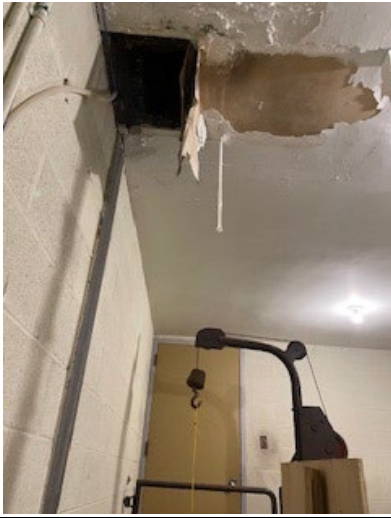
<p>13. Damaged drywall joint compound was observed in the Pool Room immediately above the stairs to the Pool Mechanical Room.</p>

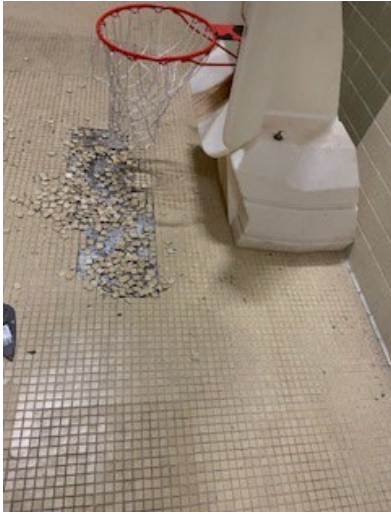
<p>14. An area of damaged ceramic tile and grout was observed in the Pool Room.</p>

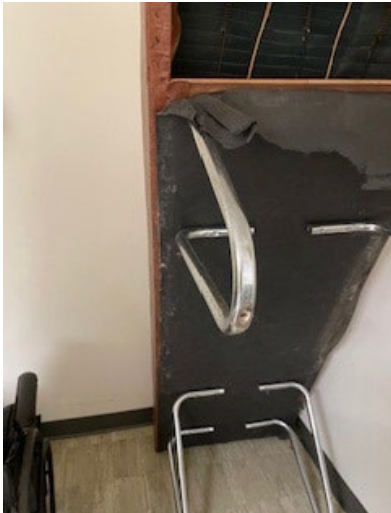
- Visible mold was observed on surfaces, wheelchairs, and the sick bed in the clinic.

<p>15. The Clinic, also referred to as the Sick Room had visible mold on surfaces, on wheelchairs and the sick bed.</p>

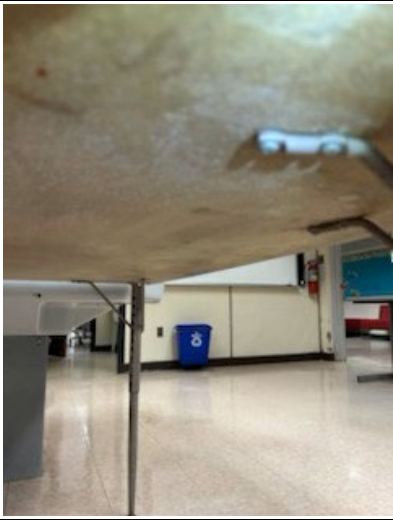
A photograph showing the underside of a table in a room. A blue object, possibly a trash can, is visible in the background.		<p>16. Visible mold was found under the table in Room 308.</p>

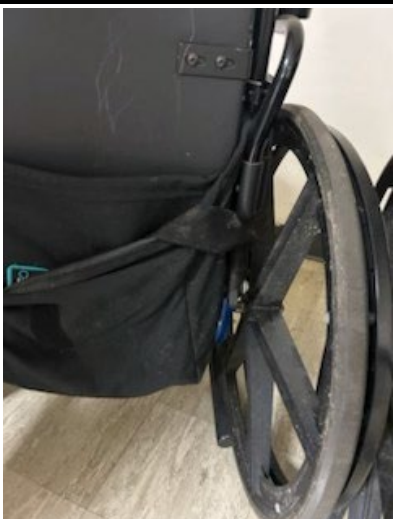
A close-up photograph of a black wheelchair. The frame shows the seat, backrest, and one of the large rear wheels. There is visible mold and staining on the black fabric of the seat.		<p>17. Visible mold and staining was found on the wheelchair in the Clinic.</p>
