## INDOOR AIR QUALITY EVALUATION REPORT

**OKEMOS PUBLIC SCHOOLS  
CORNELL ELEMENTARY SCHOOL  
4371 CORNELL ROAD  
OKEMOS, MICHIGAN 48864**

**ERG PROJECT NO.: 251047**

**PROJECT DATES: SEPTEMBER 6, 8, 12 AND 17,  
2025 FINAL REPORT DATE: OCTOBER 27, 2025**

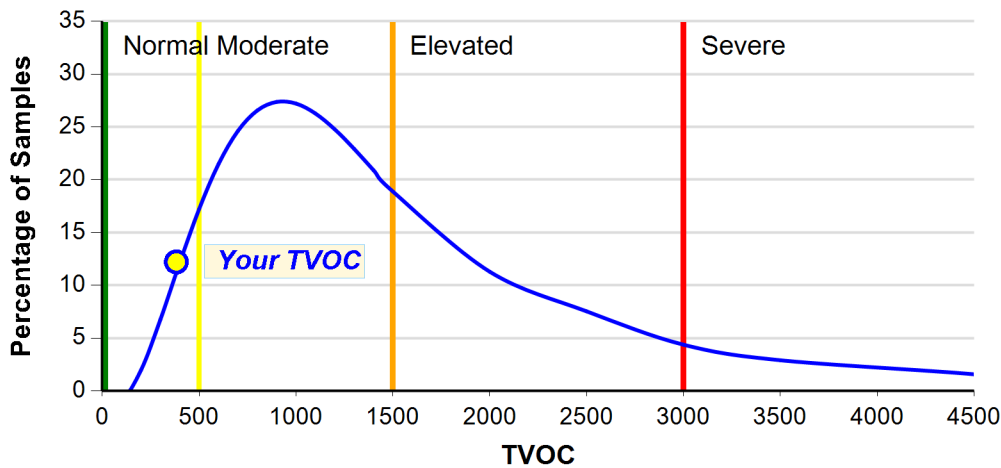
**All IAQ Survey TVOC  
Air Quality Indicator**

**The average TVOC is  
1900 ng/L**

This chart represents the TVOC distribution of over 45,000 samples. Over 80% of these samples indicate improvements in IAQ are necessary to achieve the goal of TVOC less than 500 ng/L.

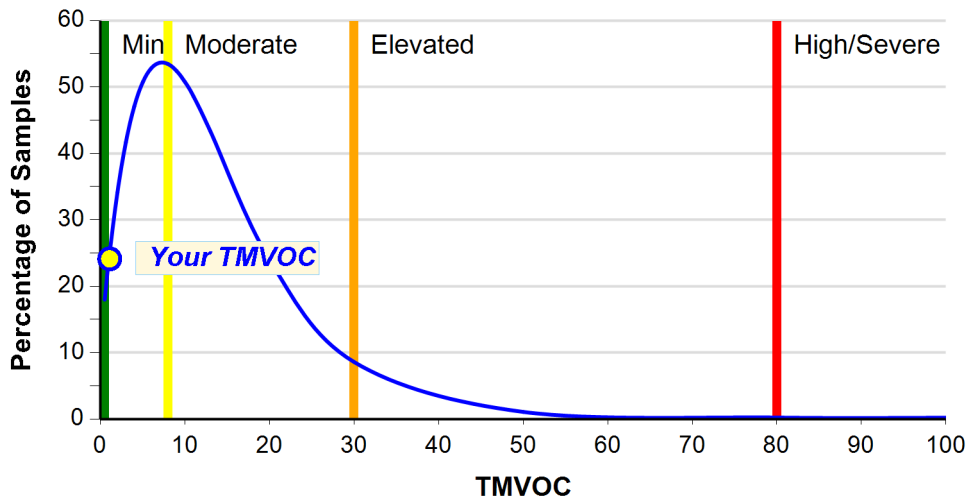
**All IAQ Survey TMVOC  
Active Mold Growth Indicator**

**The average TMVOC is 10 ng/L**

This chart represents the TMVOC distribution of over 45,000 samples. Approximately half the samples indicate that some active mold growth is occurring at the time of sample collection.

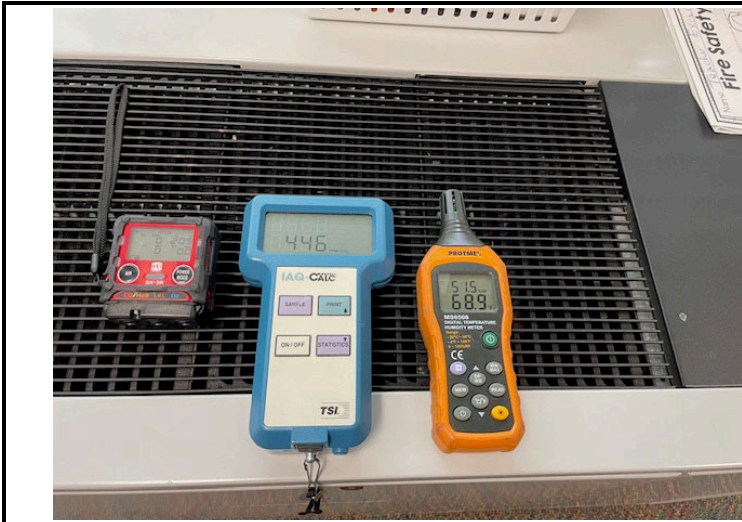
1. A variety of direct read instruments were used to assess conditions in Rooms 12 and 22 at Cornell Elementary School. Devices were placed on the operational unit ventilator supply grilles to measure incoming air in both rooms.

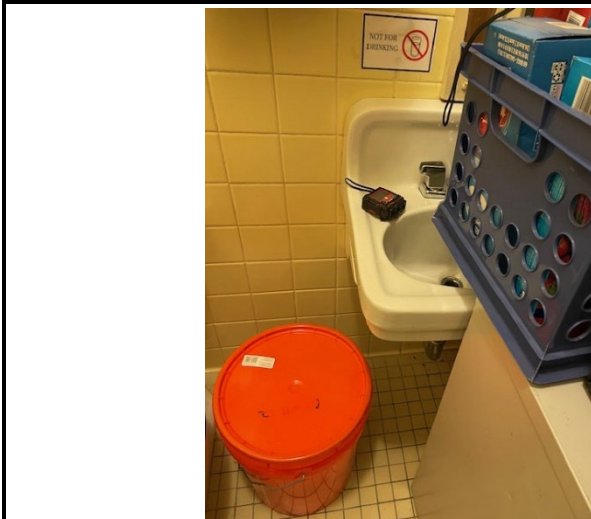
- The classroom restroom had been turned into a storage closet. The toilet held water. The water to the sink had been turned off.
- No odors were observed in the restroom.

2. The classroom bathroom in Room 22 had become a storage room. The water supply serving the sink had been turned off and water must be added periodically to the sink to keep the P trap full of water.

4. Place a formal stopper in the sink drain in the Room 22 classroom restroom -or- periodically pour water down the drain to prevent the trap from drying out. Periodically pour water in the toilet bowl to prevent it from drying out.

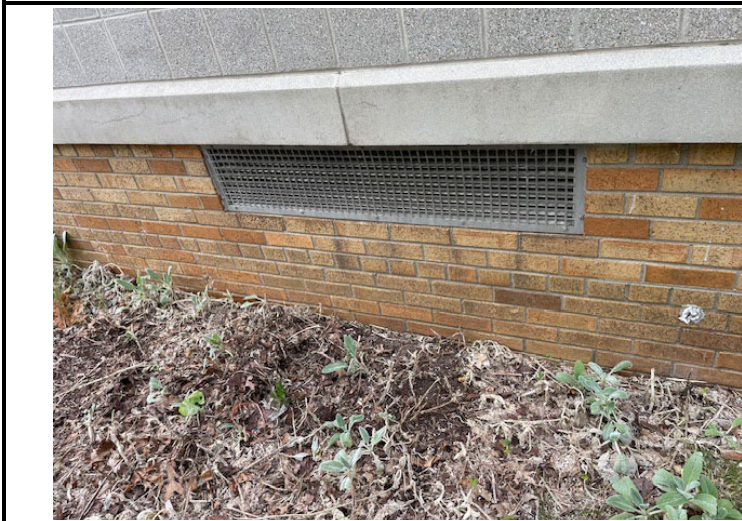
3. The Room 22 unit ventilator fresh air intake was clean and unobstructed. Dry grass and weeds can be seen below the intake grille.

7. Consider removing the unit ventilator air intake grille outside Room 22 to allow its' inspection and cleaning.
8. If odors remain after completion of the above recommendations, contact ERG and conduct additional evaluation (i.e., additional VOC testing, perform destructive testing).

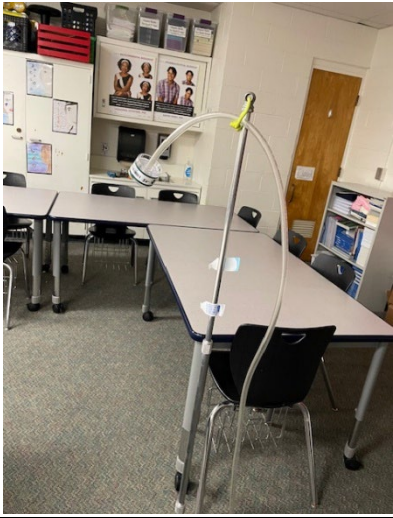
<p>4. Mold in air samples, like the sampler shown here, were collected in each room.</p>

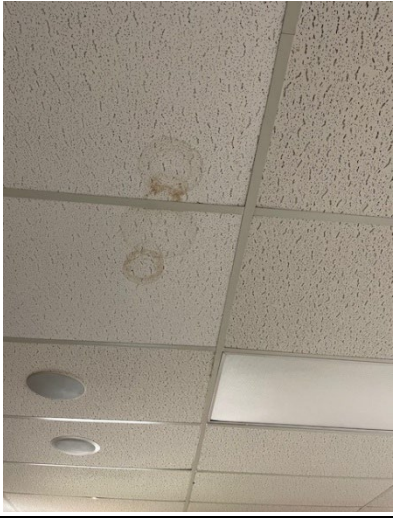
- A distinct odor of burning plastic or crayons was observed upon entry.
- Wall fans became operational as soon as the light switch was turned on.
- Two watermarked drop ceiling tiles were observed in the room.

Water-stained building materials were found in Room 22 with possible mold growth atop two drop ceiling tile.

<p>5. Two water marked drop ceiling tile were observed in Room 22.</p>

1. Occupy Room 12 as it is normally occupied.
2. Do not occupy Room 22 until such time that the source of the odor can be identified and eliminated.
3. Remove the watermarked ceiling tile from Room 22. To the extent possible, insulate the connector/clamp to reduce or eliminate condensation. Replace the water-stained and moldy drop ceiling tile with a new tile.

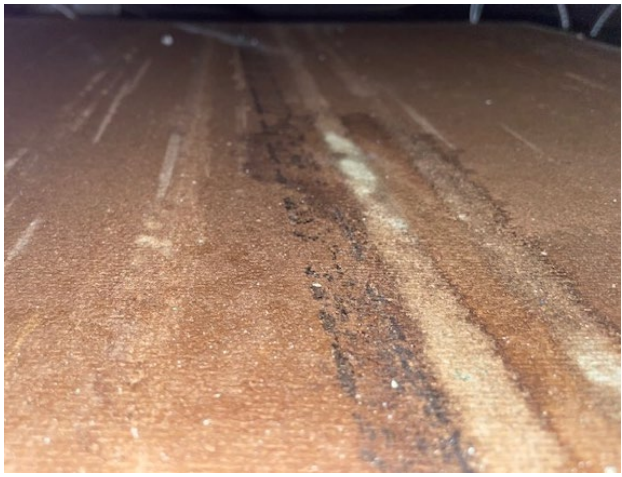
- The top side of the tiles has less than 6 square inches of suspect mold growth.
- An uninsulated pipe connection/clamp was observed above the drop ceiling tile at the location of the watermarked ceiling tile.

<p>6. A water mark and possible mold growth were observed on the top of the water marked drop ceiling tile.</p>

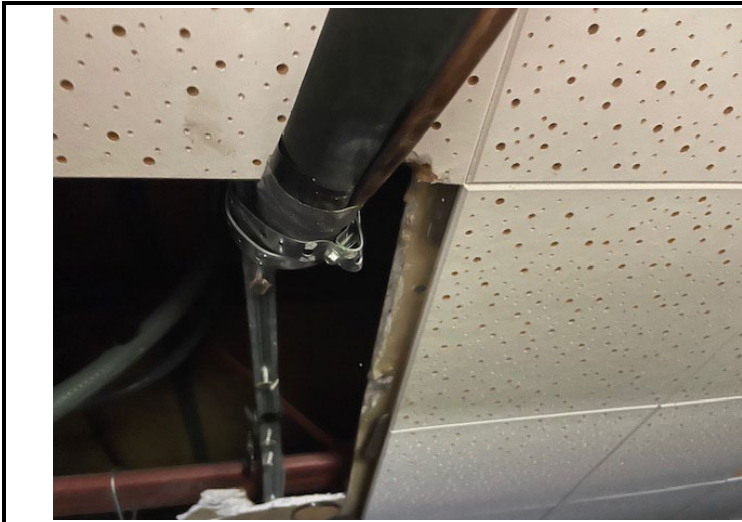
7. The water marks on the ceiling tile in Room 22 occurred directly beneath this coupler/clamp. ERG hypothesized that water from the atmosphere was condensing on metal and dripping on to the ceiling tile.

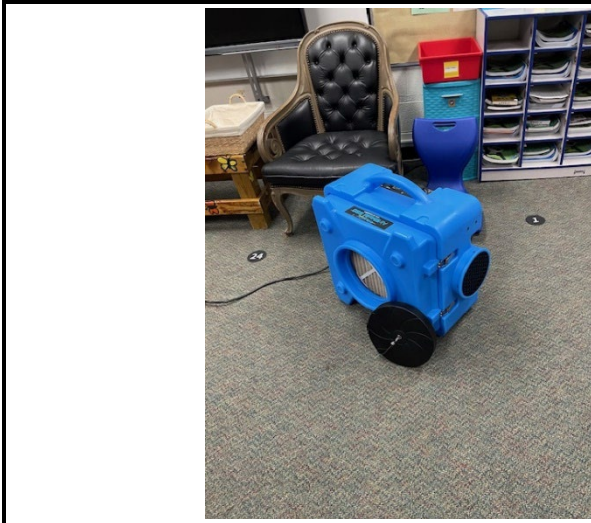
- A HEPA filter-equipped air filtration device was present in the room. The air intake vents were covered. The investigator removed one of the covers to allow improved air filtration and air circulation.

8. A High Efficiency Particulate Air (HEPA) filter equipped air filtration device was operational in Room 22 at the time of the evaluation.

5. Repair the holes in the exterior stucco outside Room 22 and along the east wall of the building.
6. Improve training of Operations Department staff so they better understand the operation of the HEPA-filtered air filtration devices.

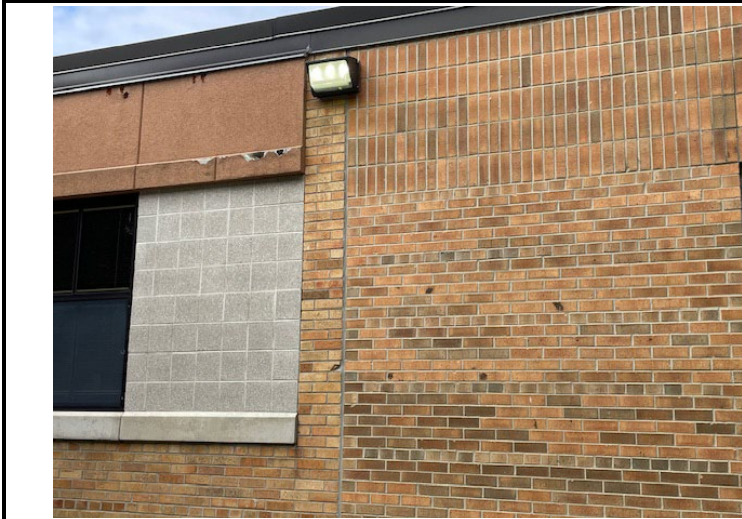
9. Damage to the exterior stucco was observed outside Room 22 and along the Cornell Road side of the building.
