## INDOOR AIR QUALITY EVALUATION REPORT

**KINAWA MIDDLE SCHOOL  
1900 KINAWA DRIVE  
OKEMOS, MICHIGAN 48864**

**ERG PROJECT NO.: 250873**

**PROJECT DATE: JUNE 18, 2025**

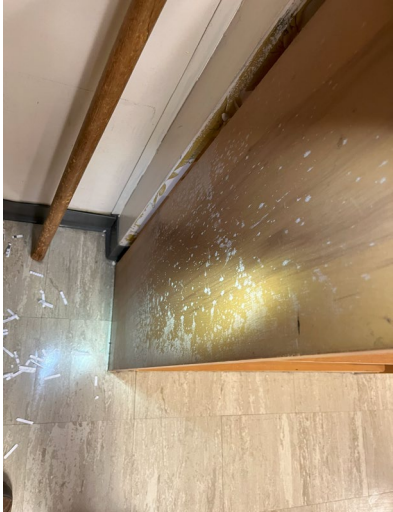
Mold was found on the bookcases and shelves in the Break Area. Mold was found on some of the furniture in the Guidance Office. This appears to be surface mold due to past high humidity conditions.

A photograph showing a close-up of a wooden cabinet in a break area. The cabinet surface is covered with a dense, yellowish-green mold. A bright light source, possibly a flashlight, is visible on the left, casting a beam of light onto the moldy surface.	<p>1. Mold was observed on the cabinet in the Break Area.</p>

1. Employ an HVAC contractor to ensure the ventilation system servicing the Main Office and Guidance Office is fully functional and is able to control the relative humidity in the area.
2. Retain a mold remediation professional (GFL) to clean and disinfect the moldy furniture in the Main Office and Guidance Office. Discard moldy furniture which is planned to be replaced.
3. Remove the water-stained ceiling tile and replace with new tile.
4. Conduct air filtration in the Reception Area to reduce the number of airborne synthetic fibers. The use of a commercial air filtration device (AFD) with high efficiency particulate air (HEPA) filters is recommended. Operate the AFD for a period of at least 24 hours.
5. Complete mold remediation in the 200 wing as soon as possible and restart the HVAC system serving that area.

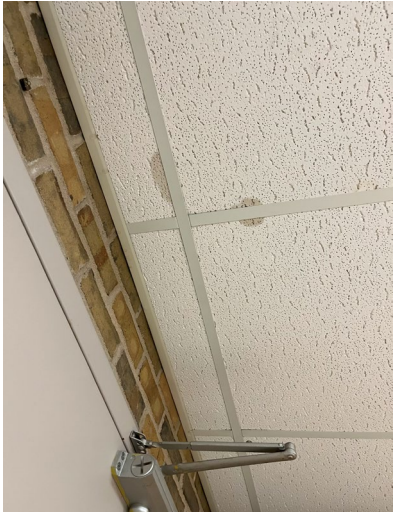
Water-stained building materials were found in the inspected areas, including ceiling tiles. The source of the water responsible for staining the tile was not evaluated.

A photograph of a drop ceiling tile in a break area near a door. The tile is white and shows significant water staining, appearing as a large, irregular brownish-yellow patch. A metal door handle is visible in the lower left corner of the frame.	<p>2. Water stained ceiling tile was observed in the Break area near the door.</p>

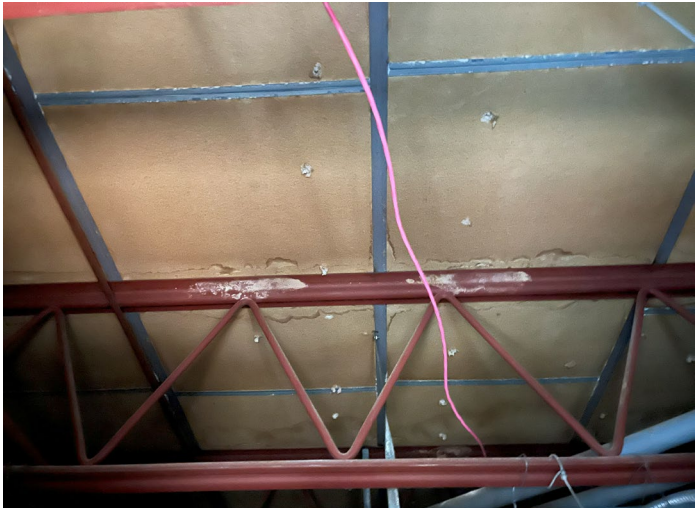
- No musty or other odors were observed immediately upon entry.
- Water stains were observed on the gypsum decking above the drop ceiling tile. No visible mold was found.
- No visible mold was observed on any wooden or other surface.
- The carpet was stained but otherwise appeared to be in good condition.
- The overall level of dust was low.

A photograph showing the underside of a drop ceiling tile in the Main Office. The decking is made of wood and shows significant water staining, appearing as a large, irregular brownish-yellow patch. A red metal support structure is visible in the foreground, and a pink cable runs across the top of the frame.	<p>3. Water stained decking above the drop ceiling tile in the Main Office.</p>
