## INDOOR MOLD EVALUATION REPORT

**OKEMOS PUBLIC SCHOOLS  
CORNELL ELEMENTARY SCHOOL  
4371 CORNELL ROAD OKEMOS,  
MICHIGAN 48864**

**ERG PROJECT NO.: 250960  
PROJECT DATE: JULY 17 AND 21, 2025  
FINAL REPORT DATE: AUGUST 18, 2025**

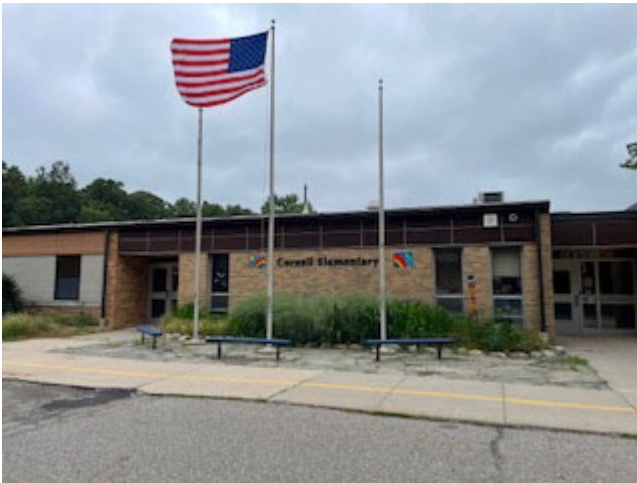
1. Cornell Elementary School as viewed from Cornell Road.

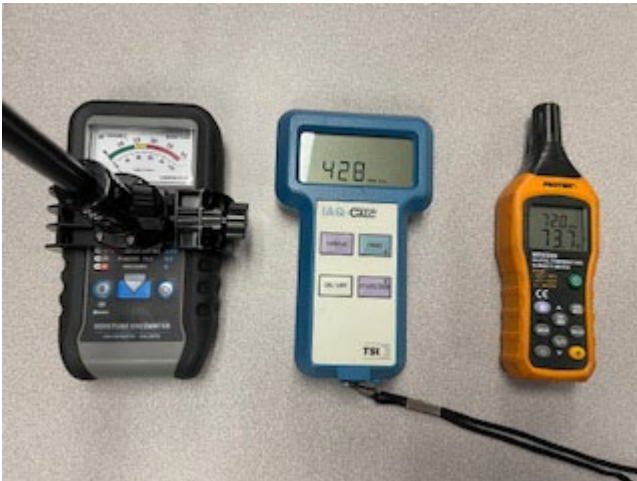
2. A number of instruments were used during the mold evaluation including, from left to right, a Tramex moisture meter, TSI Carbon Dioxide Meter and Protmex temperature and humidity probe.
